Asbestos Inspection Report
for
Newington Town Hall
131 Cedar Street
Newington, CT 06108

Prepared
for
Town of Newington
Facilities Department
131 Cedar Street
Newington, CT 06108

February & March 2015

EnviroMed Project # IH-15-026

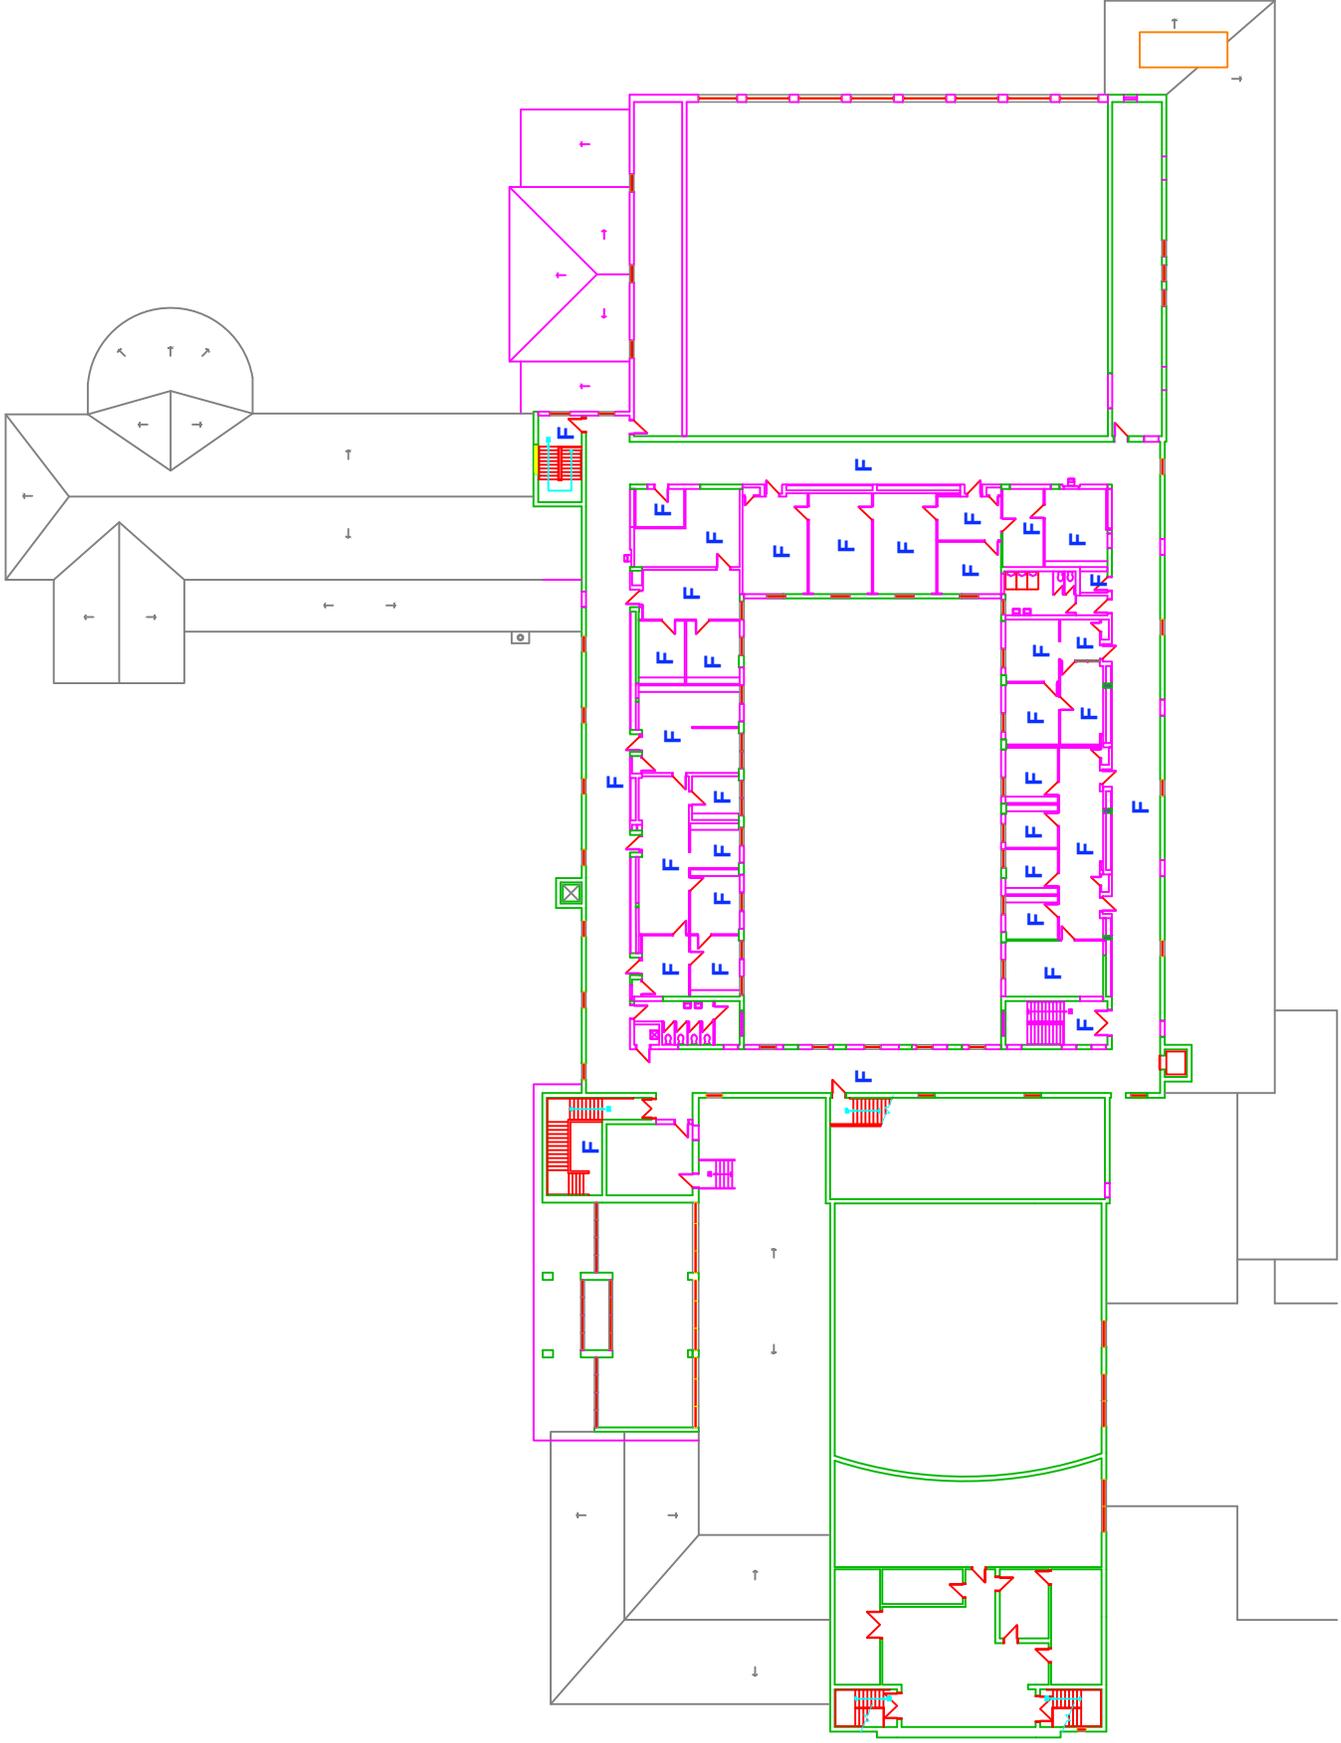
**ASBESTOS FLOORING LOCATION PLAN
NEWINGTON TOWN HALL - UPPER LEVEL
F = ASBESTOS-CONTAINING VINYL FLOOR TILE AND/OR MASTIC**

Asbestos Containing Material - Flooring

The following asbestos-containing flooring materials were found in Newington Town Hall.

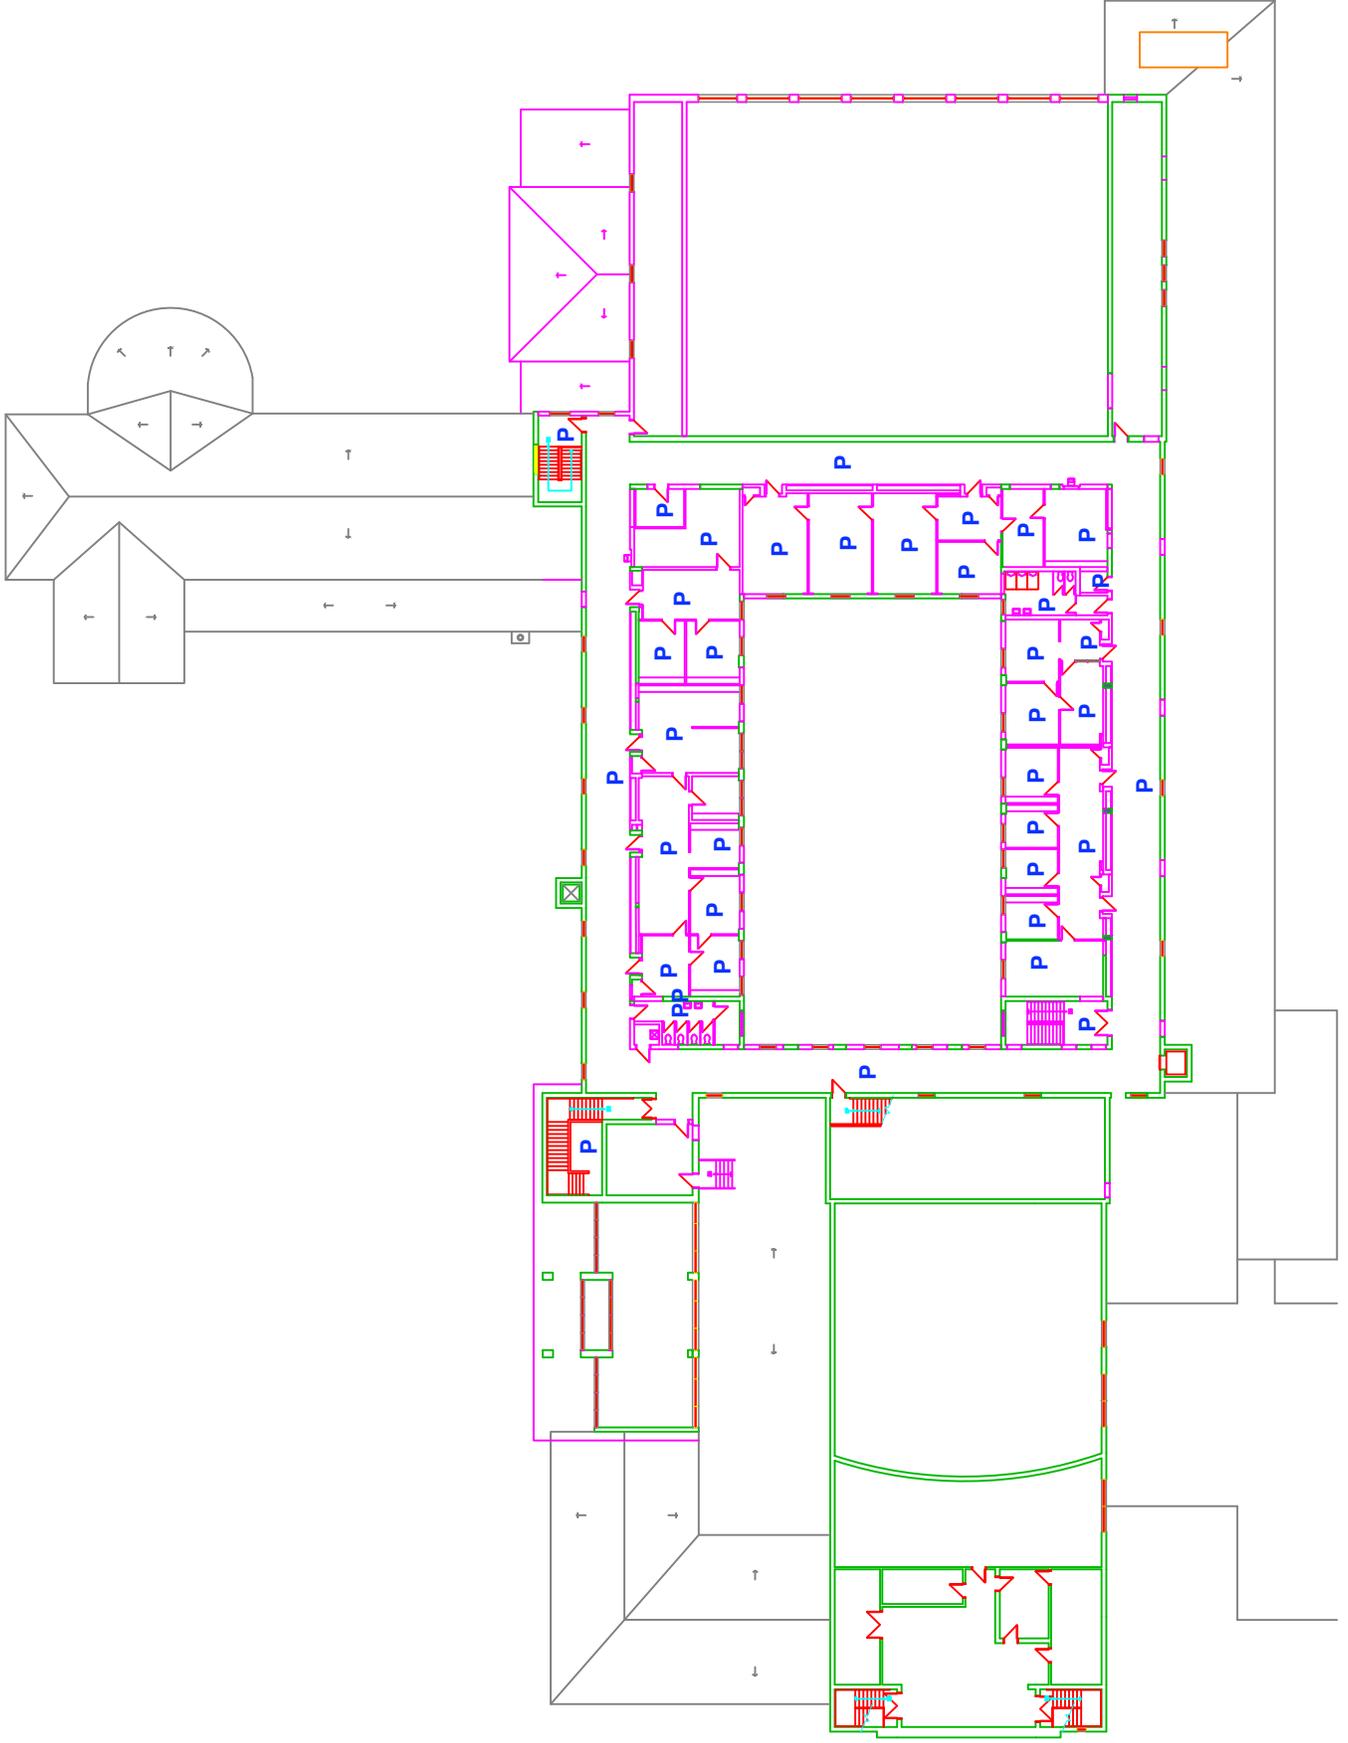
**ASBESTOS CEILING PLASTER LOCATION PLAN
NEWINGTON TOWN HALL - UPPER LEVEL
P = ASBESTOS-CONTAINING ACOUSTICAL CEILING PLASTER PRESENT**

Acoustical ceiling plaster

Note: 2x4 ceiling systems have been hung from the acoustical ceiling plaster above. The demolition of the 2x4 ceiling systems will release asbestos from the acoustical plaster above. 2x4 ceiling systems located below acoustical plaster ceilings should be considered asbestos-contaminated for any renovation or demolition activity.

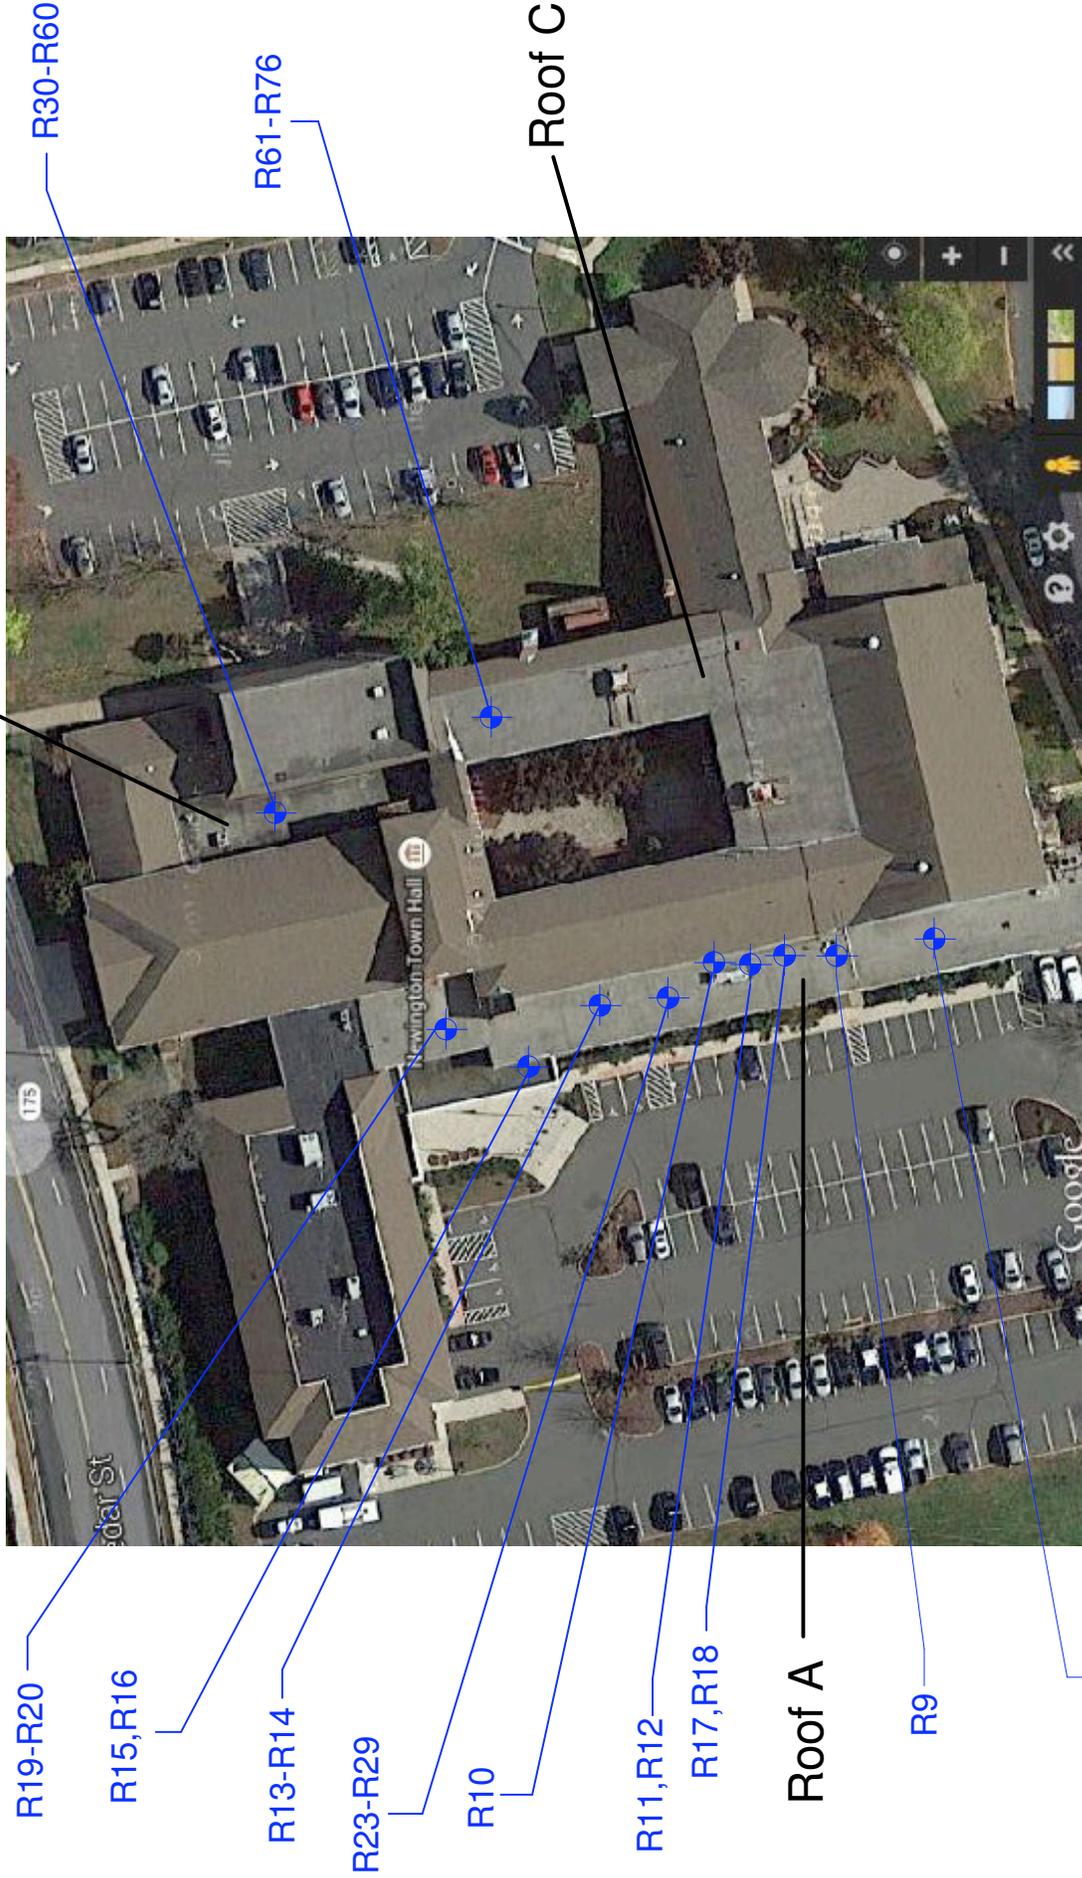
Newington Town Hall - Roof Asbestos Sample Locations March 19, 2015

Sample Number	Location	Material Sampled	Percent Asbestos
R1	Roof A	Roof felt layer #1	NAD
R2	Roof A	Roof felt layer #2	NAD
R3	Roof A	Roof felt layer #3	NAD
R4	Roof A	Roof felt layer #4	NAD
R5	Roof A	Roof felt layer #5	NAD
R6	Roof A	Felt attached on top of fiberglass roof insulation	NAD
R7	Roof A	Base sheet on top of concrete roof deck	NAD
R8	Roof A	Concrete roof deck	NAD
R9	Roof A	Brick wall roofing felt	NAD
R10	Roof A	Pitch box	10%
R11	Roof A	HVAC top flashing paper	NAD
R12	Roof A	HVAC bottom flashing layer	20%
R13	Roof A	Chimney water proof	NAD
R14	Roof A	Chimney water proof	NAD
R15	Roof A	Edge flashing	25%
R16	Roof A	Old window caulk	NAD
R17	Roof A	New window caulk	NAD

R18	Roof A	Louver caulk	1%
R19	Roof A	Black tab asphalt roof shingle	NAD
R20	Roof A	Top asphalt roof shingle	NAD
R21	Roof A	Second layer edge drip roof layer	NAD
R22	Roof A	Second layer edge drip roof layer	NAD
R23	Roof A	Felt #1	NAD
R24	Roof A	Felt #2	NAD
R25	Roof A	Felt #3	NAD
R26	Roof A	Felt #4	NAD
R27	Roof A	Felt #5	NAD
R28	Roof A	Base membrane	NAD
R29	Roof A	Base sheet roof membrane	NAD
R30	Roof B	Felt #1	NAD
R31	Roof B	Felt #2	NAD
R32	Roof B	Felt #3	NAD
R33	Roof B	Felt #4	NAD
R34	Roof B	Felt #5	NAD

R35	Roof B	Felt attached on top of fiberglass roof insulation	NAD
R36	Roof B	Base sheet on top of concrete roof deck	NAD
R37	Roof B	Concrete roof deck	2%
R38	Roof B	Window caulk	NAD
R39	Roof B	Asphalt shingles	NAD
R40	Roof B	Asphalt shingles	NAD
R41	Roof B	2 nd layer drip edge roof layer	NAD
R42	Roof B	Black roof cement on valley and roof edge	NAD
R43	Roof B	Black roof cement on valley and roof edge	NAD
R44	Roof B	Window caulk	NAD
R45	Roof B	Window glazing	NAD
R46	Roof B	Window glazing	NAD
R47	Roof B	Roof walking pad	NAD
R48	Roof B	Roof walking pad	NAD
R49	Roof B	Gray caulk, metal step flashing	NAD
R50	Roof B	Gray caulk, metal step flashing	NAD
R51	Roof B	Door caulk	NAD

R52	Roof B	Roof drain flashing	2%
R53	Roof B	Roof drain flashing	15%
R54	Roof B	Plaster soffit	NAD
R55	Roof B	Plaster soffit	NAD
R56	Roof B	Plaster soffit	NAD
R57	Roof B	Perimeter flashing under window felt #1	NAD
R58	Roof B	Perimeter flashing under window felt #2	NAD
R59	Roof B	Perimeter flashing under window felt #3	NAD
R60	Roof B	Pitch pocket	NAD
R61	Roof C	Felt #1	NAD
R62	Roof C	Felt #2	NAD
R63	Roof C	Felt #3	NAD
R64	Roof C	Felt #4	NAD
R65	Roof C	Felt #5	NAD
R66	Roof C	Tar & insulation	NAD
R67	Roof C	Base sheet	NAD
R68	Roof C	Roof vent perimeter tar flashing	10%

R69	Roof C	Roof vent perimeter tar flashing	15%
R70	Roof C	Pitch pocket	5%
R71	Roof C	Perimeter flashing	15%
R72	Roof C	HVAC rooftop panel caulking	NAD
R73	Roof C	HVAC rooftop panel caulking	NAD
R74	Roof C	HVAC rooftop dunnage/ perimeter flashing	NAD
R75	Roof C	HVAC rooftop dunnage/ perimeter flashing	NAD
R76	Roof C	Asphalt roof shingle with tab	20%

Note: Confirmatory testing is recommended for this roof deck
