## I. Introduction

Owens Realty Services has been retained to provide consulting services to provide a conditions assessment, inclusive of a visual inspection and Code compliance review of the outdoor swimming pools at Mill Pond Park.

## II. Executive Summary

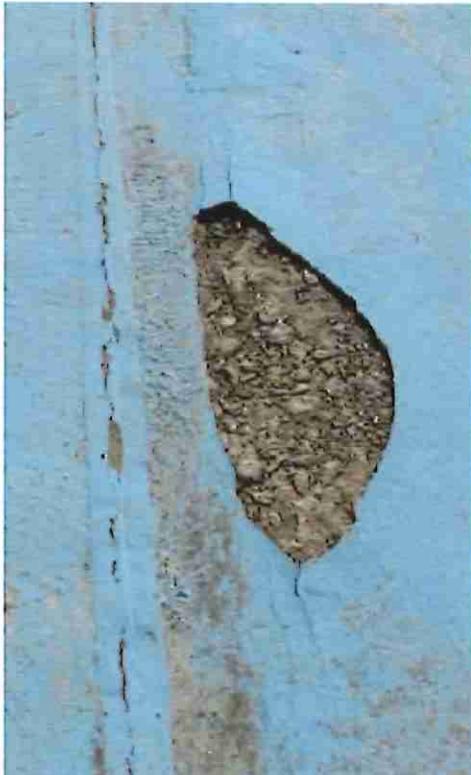
Delamination adjacent to construction joint

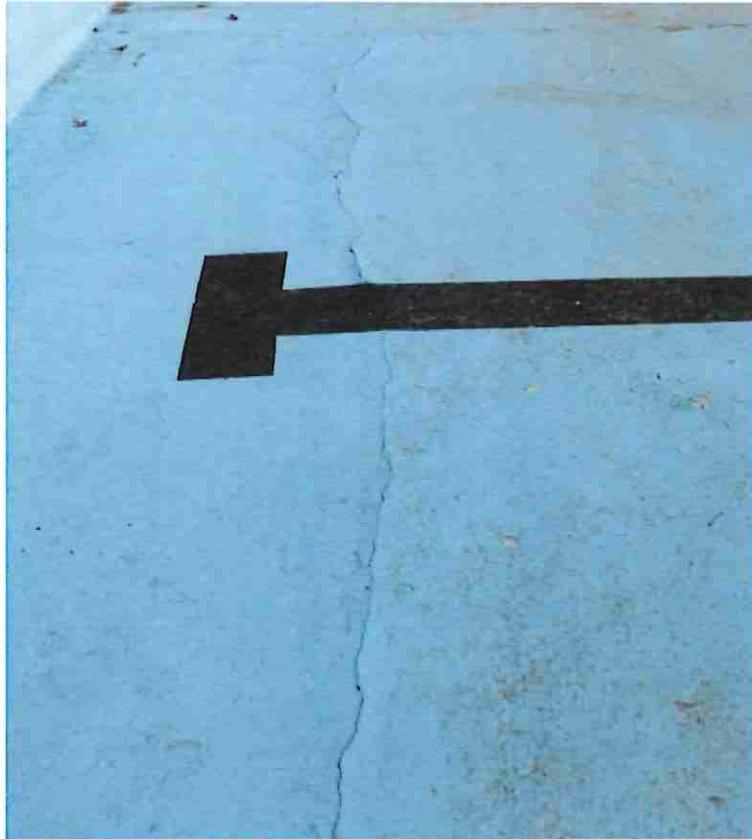
Typical crack in pool floor

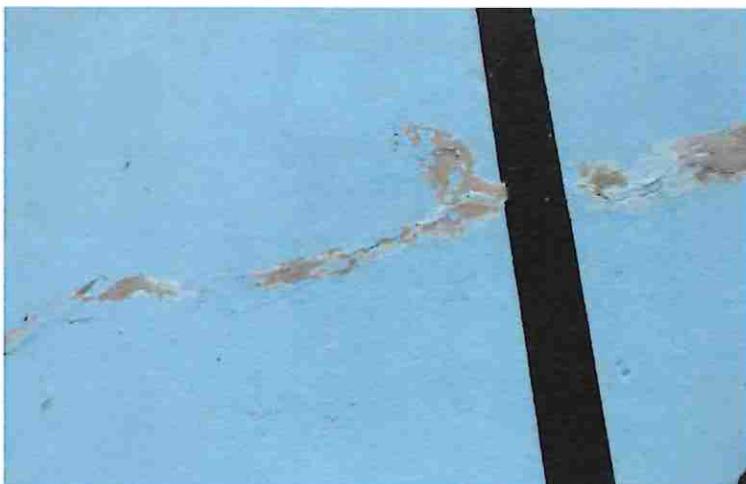
Previously repaired crack in pool floor with failure of repair materials

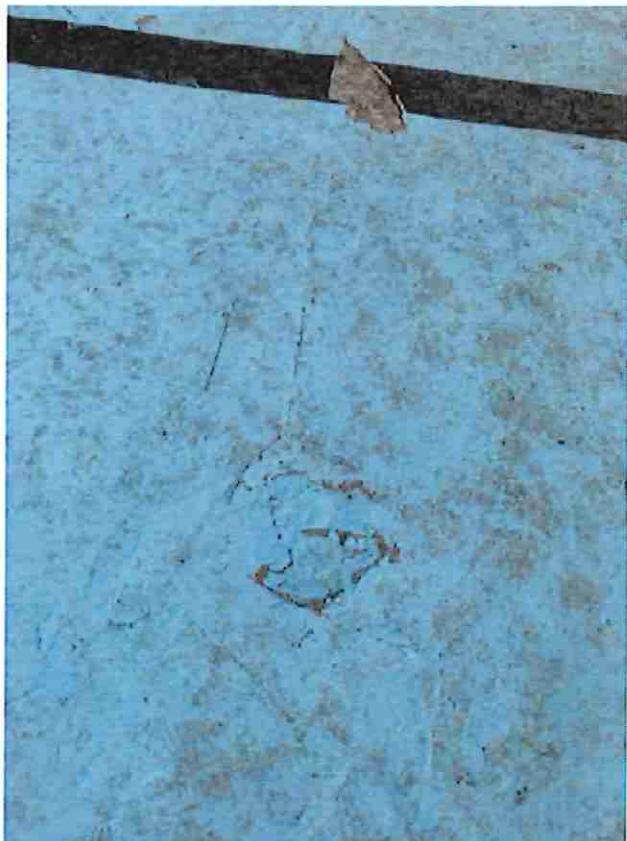
Multiple delaminations along the edge of crack

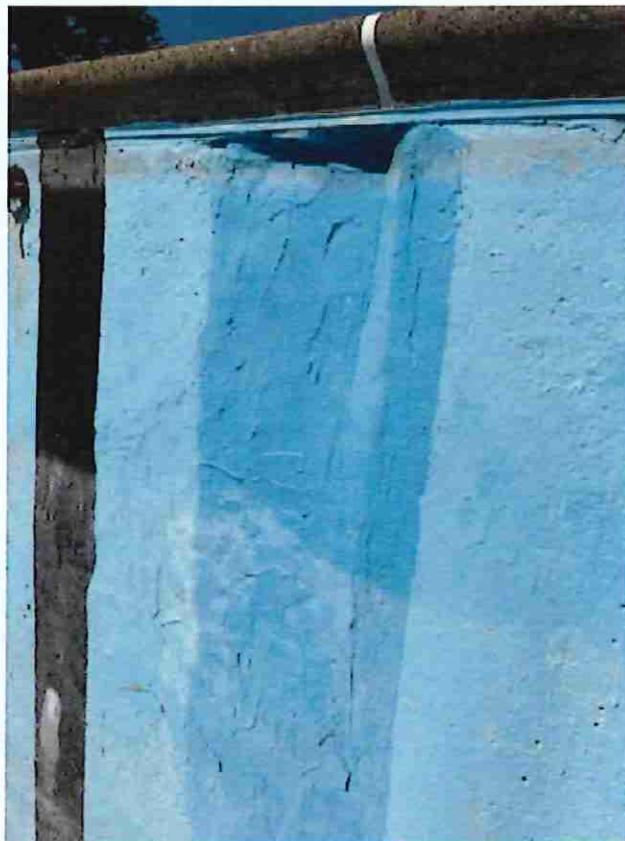
Significant spall of approximately 4-inches deep

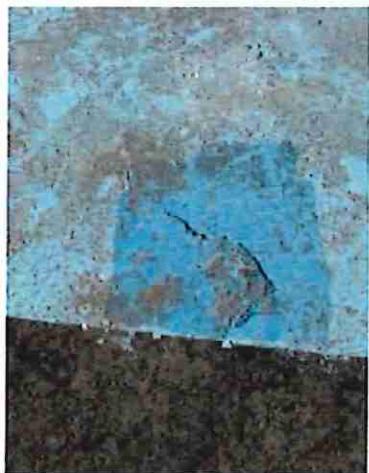
Previously repaired areas in pool floor with failure of repair materials

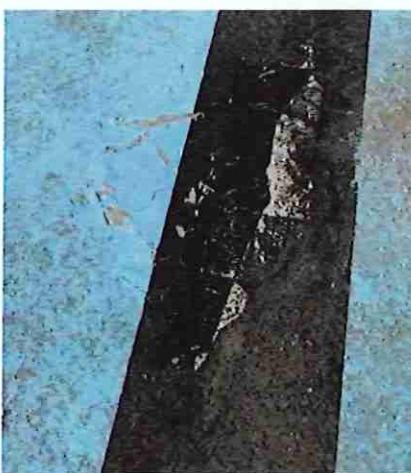
Many of the spalled areas and delaminated areas occur along cracks, which means water penetration is prevalent. In this pool, particularly in the deeper end, water is leaking out of the pool, but groundwater is pushing into the pool. This limits water loss as pressures are equalized, but saturates concrete and cause the deterioration seen throughout the pool.

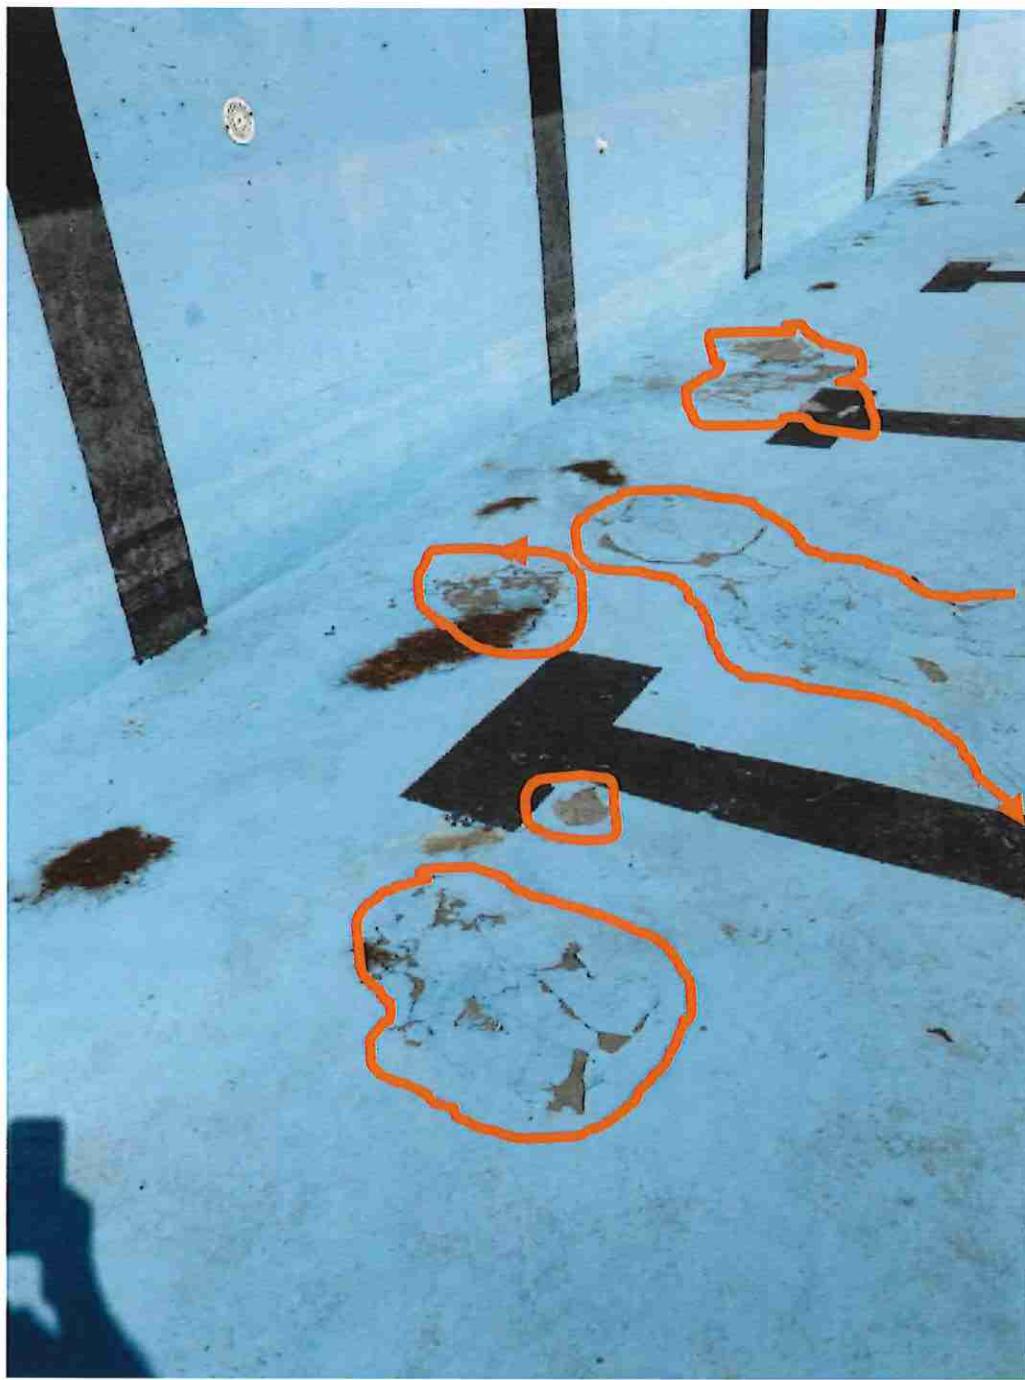
Broad areas of spalling and delamination

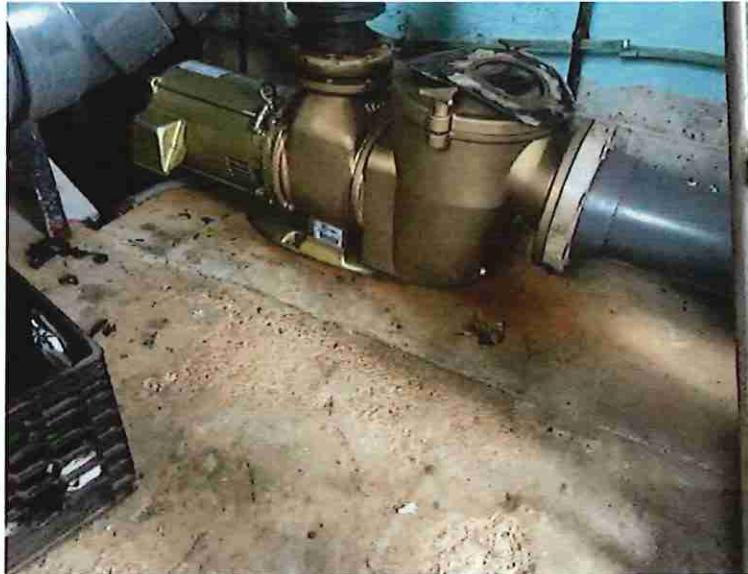
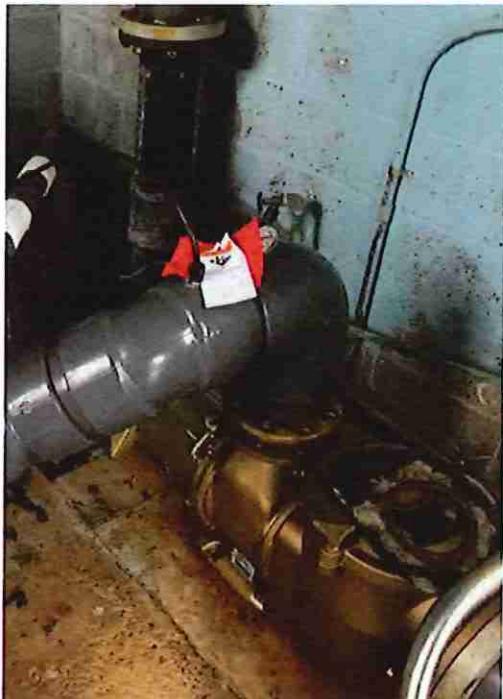
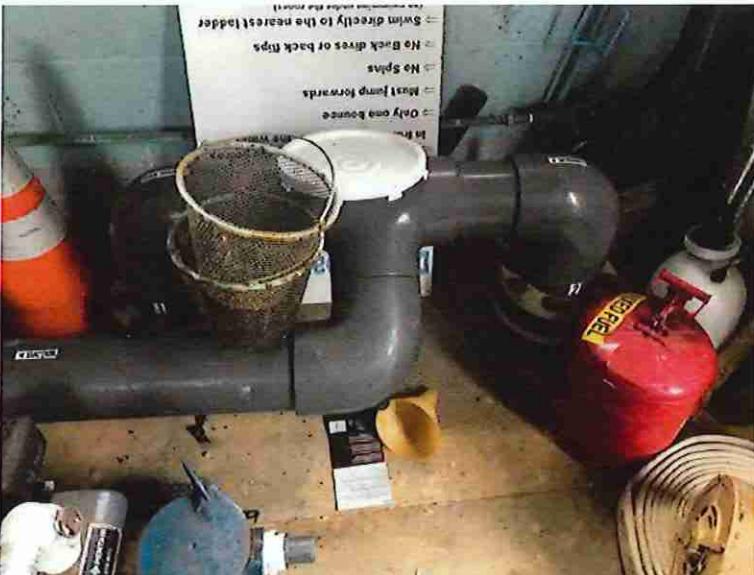
10 HP pool recirculation pump draws water in direct suction from skimmers and main drains.

- Piping is undersized and not in compliance with DPH Regulations.
- Pump should be on housekeeping pad and bolted down to limit vibration that could break fittings and damage pump.
- System is in direct suction without an anti-entrapment device. At calculated velocities, the drains are not VGB compliant, even if covers are certified.

Above: 10 HP recirculation pump.  
Below Right: Main drain and skimmer suction piping.  
Below Left: Pump discharge to Filters

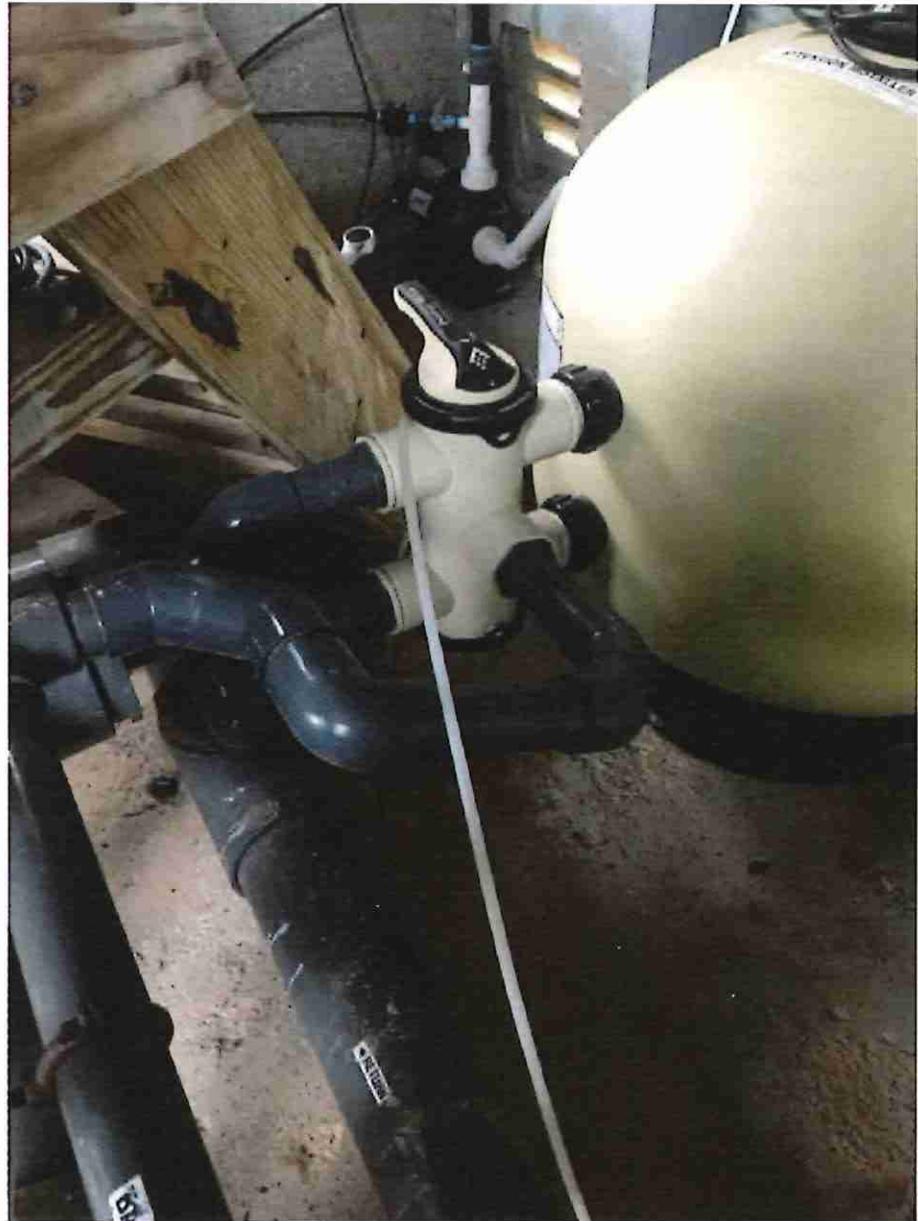
Filtration is accomplished by means of five, Pentair TRC 140 high rate sand filters. Each is fed from a 2-inch pipe, connected to the main 6-inch supply and return.

- Piping is undersized and not in compliance with DPH Regulations.
- There are no throttling valves or flow meters at each filter to confirm that each are flowing at the same rate.

Typical filter piping and multi-port valve. Position of the valve determines filter mode –vs– backwash mode.

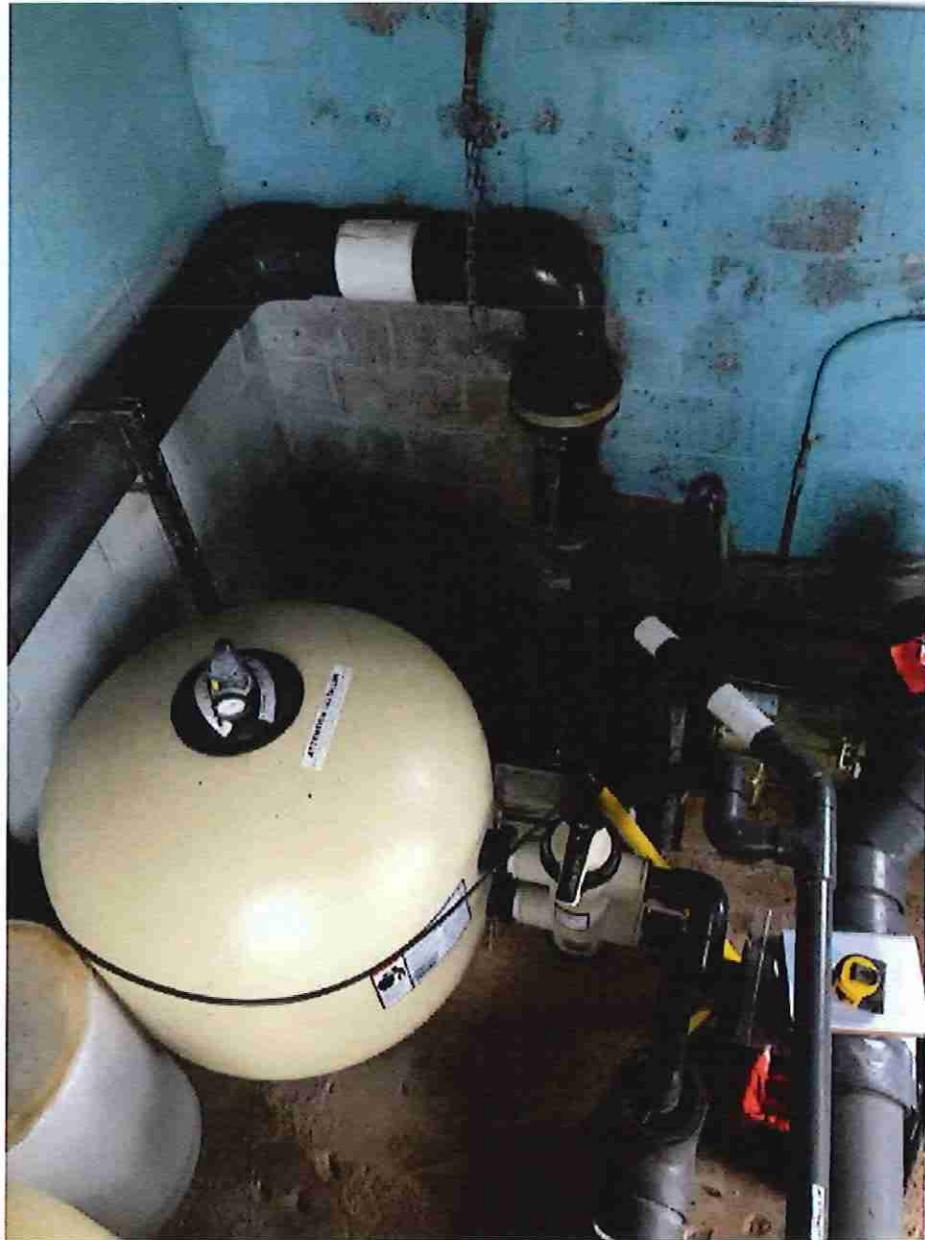
When the filter is in backwash mode, it discharges dirty filter water to a collector pipe that connects to cast-iron waste piping in the pit.

- It appears the backwash discharge is a direct connection to sewer, which is not DPH compliant, as an air-gap is required. The current arrangement could allow waste water to siphon back into the pool system.

Typical filter piping and multi-port valve. Position of the valve determines filter mode –vs– backwash mode.

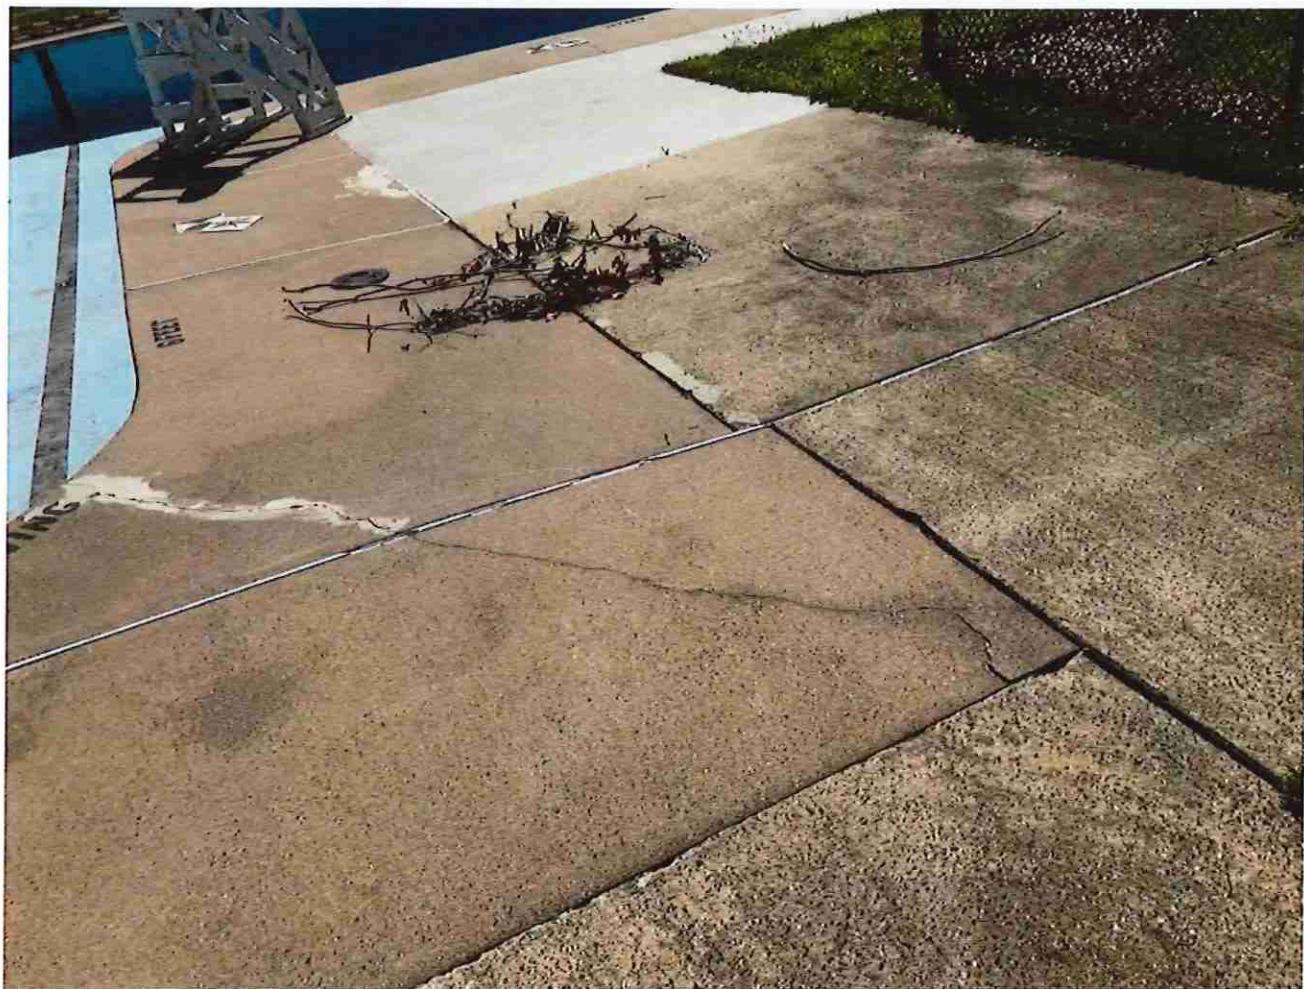
Typical deck conditions. Note 1990's vintage decking closest to pool, original decking in foreground and recently replaced decks toward the back of the photo.

1990's vintage decking is generally in good condition, though there are some significant cracks and areas of damage. Differential settlement has also caused misalignments and failed sealant joints exacerbates freeze/thaw damage.

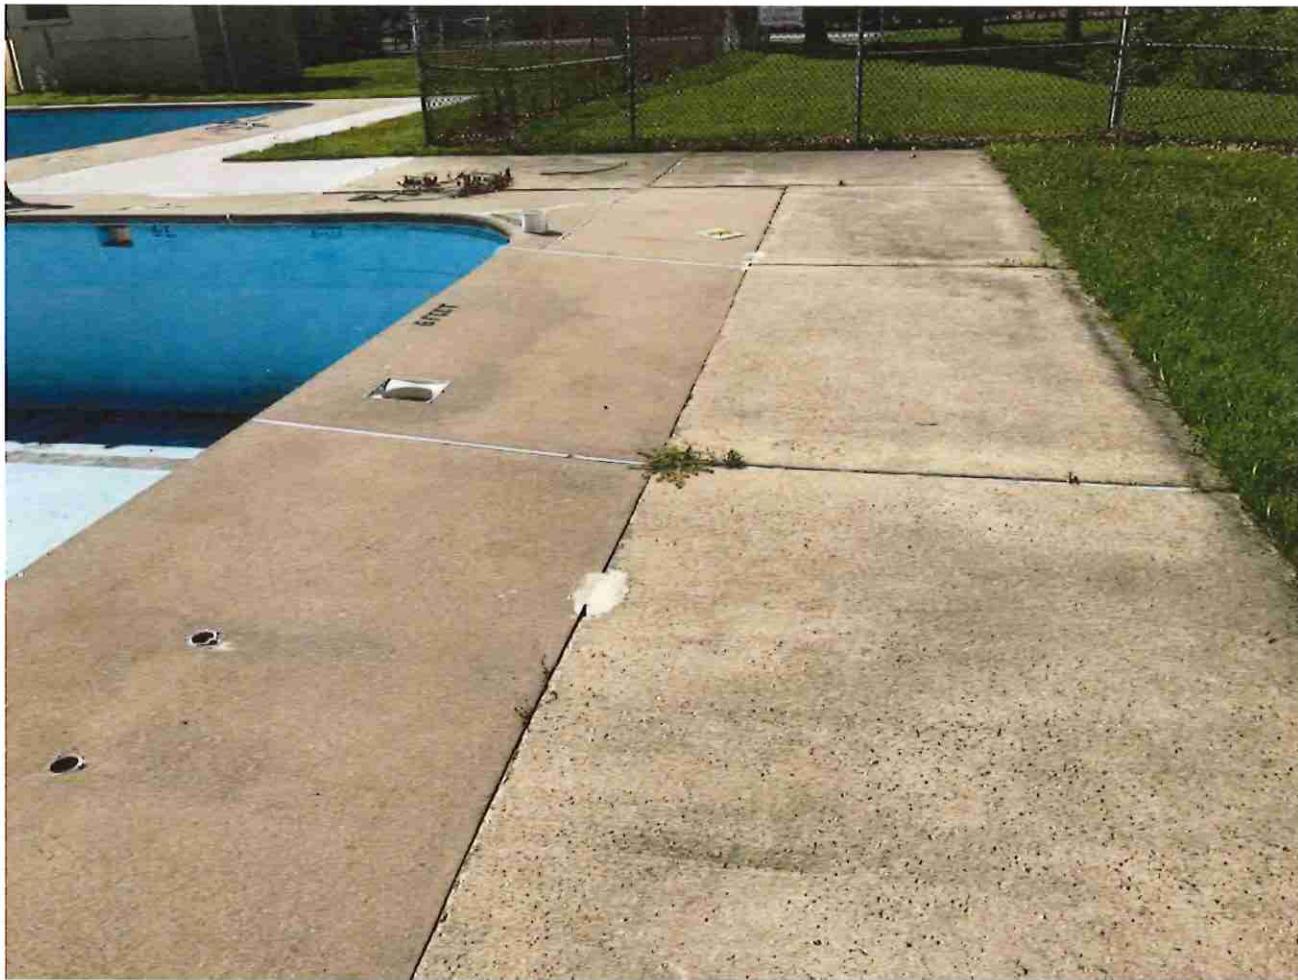
Deck pitch at the slab adjacent to the pool exceeds the ADA allowable cross pitch of 1:48. This maximum slope must be maintained for an accessible route from the bathhouse to the HCA Lift Chair and the Steps.

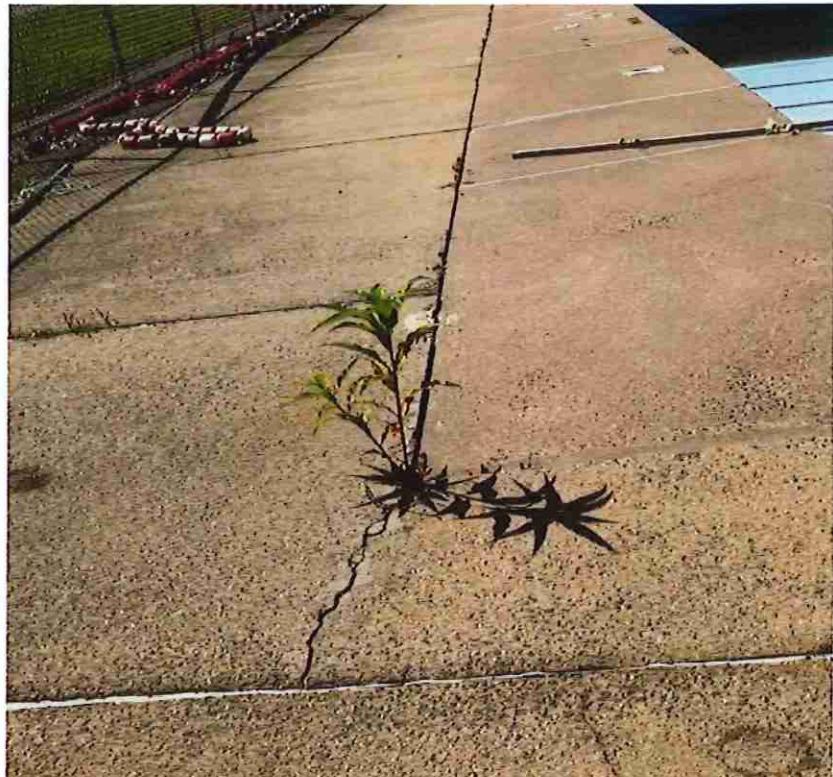
Failed sealant joints and cracks allow water penetration.

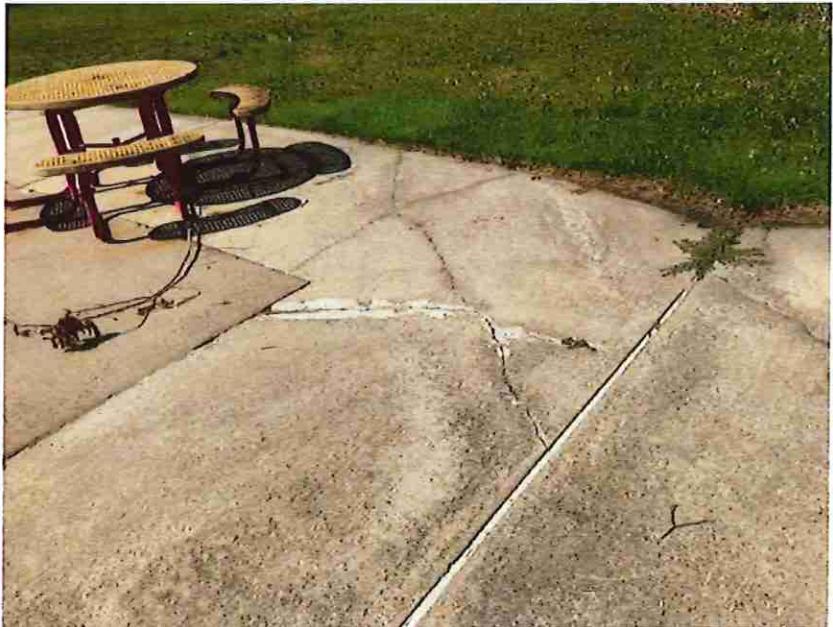
Miscellaneous cracking

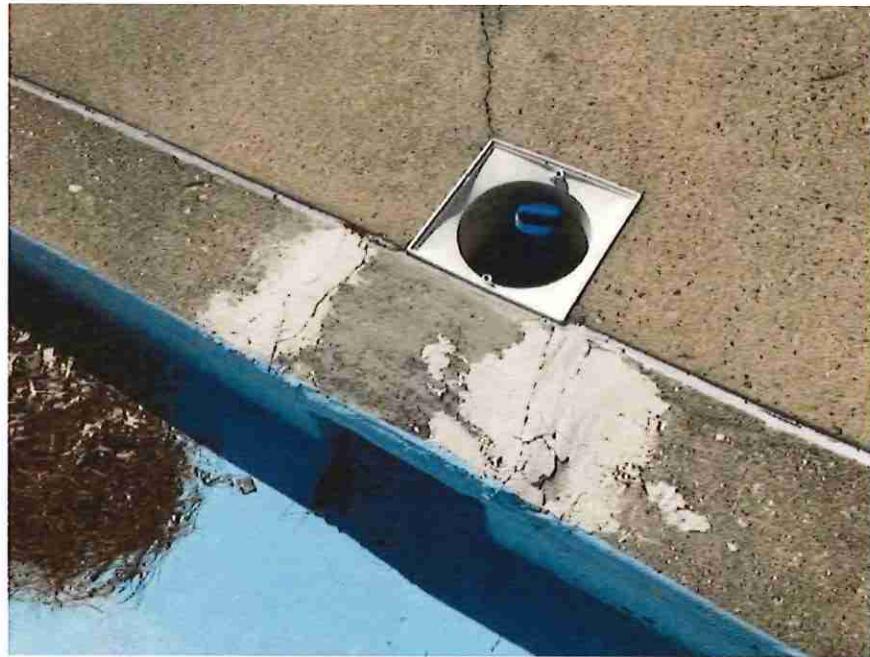
Right: Cracked and damaged concrete at skimmer boxes.

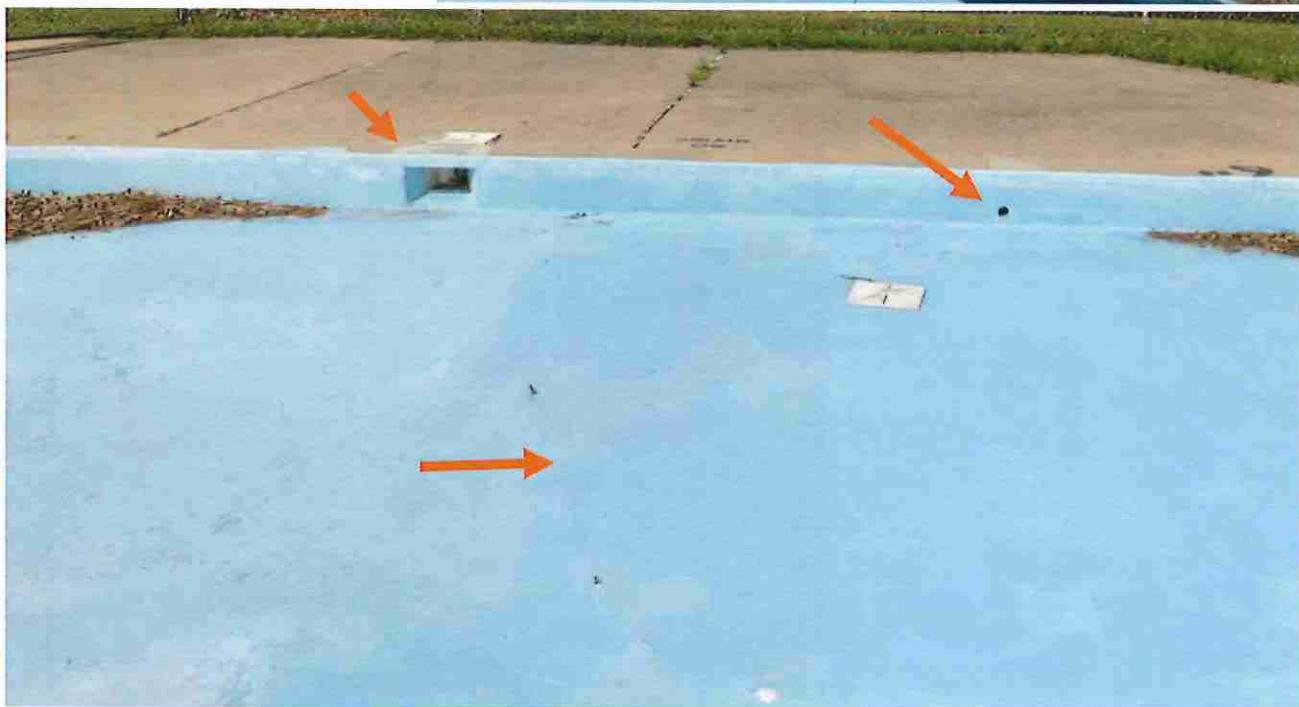
Below: Crack across pool, and vertically at inlet fitting and skimmer.

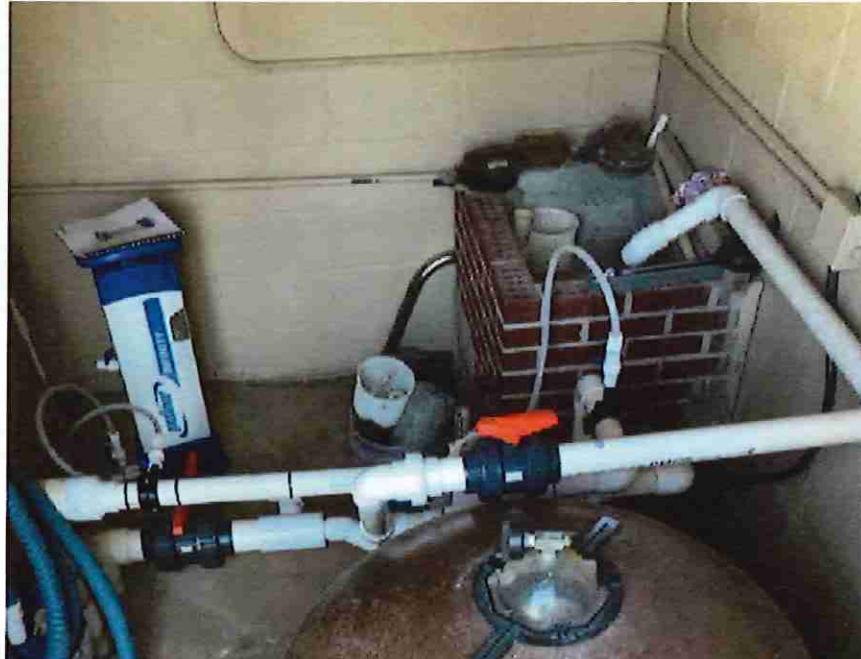
Right: High rate sand filter, not rated for commercial use.

Piping and equipment is sized properly for flow, but drains are not VGB compliant and a vacuum release system should be installed.

Air gap at backwash is insufficient.

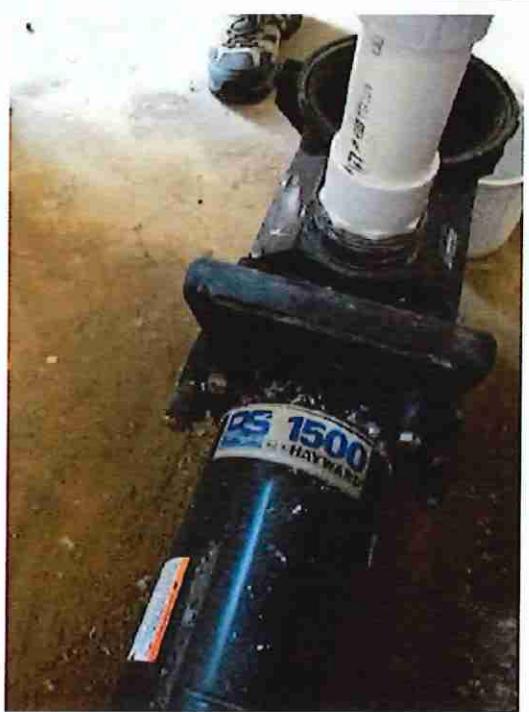
Below: 1 1/2 HP pool recirculation pump.

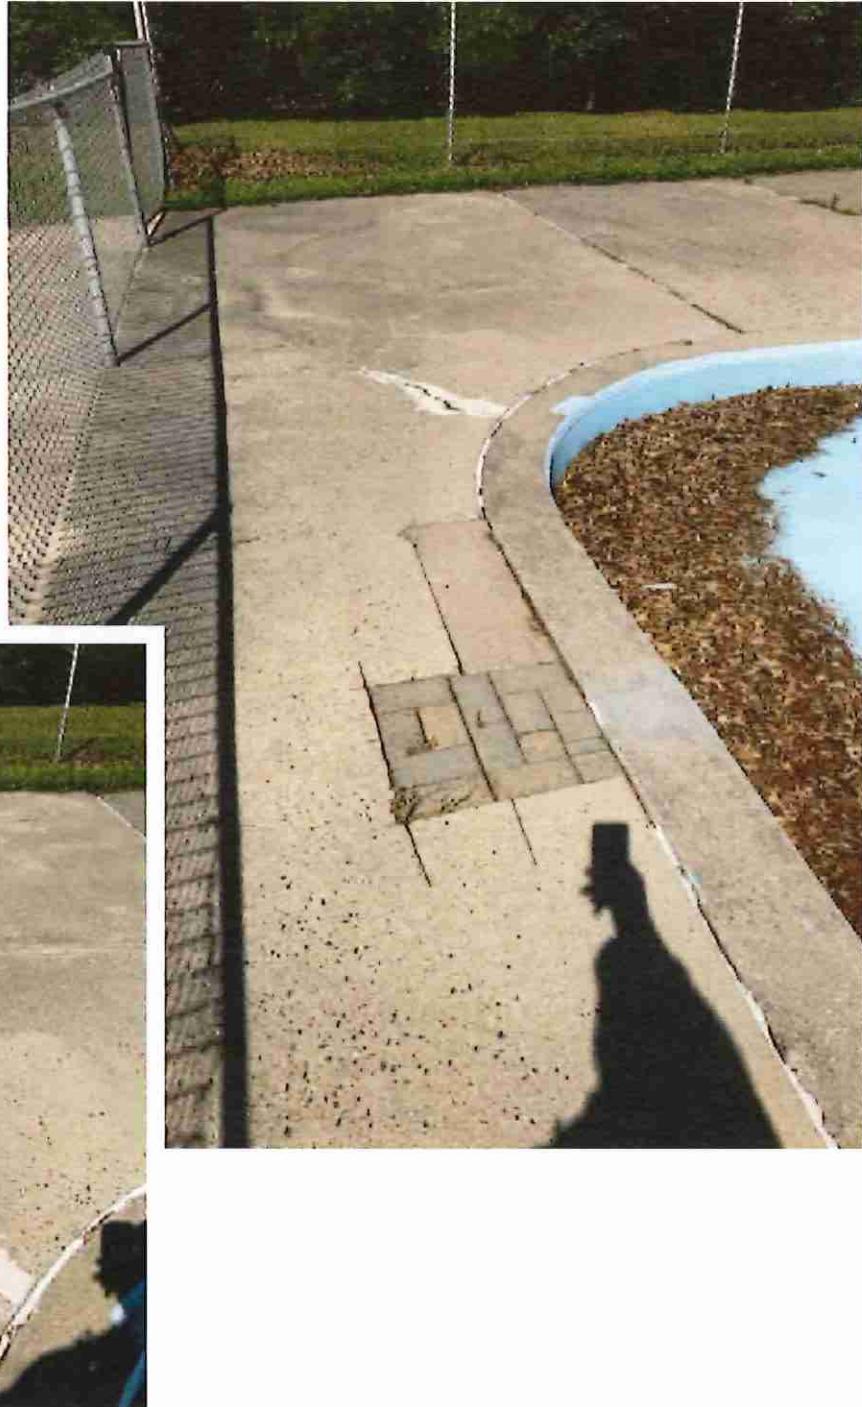
Cracked deck, repaired areas and failed sealant joints in deck allow water infiltration.

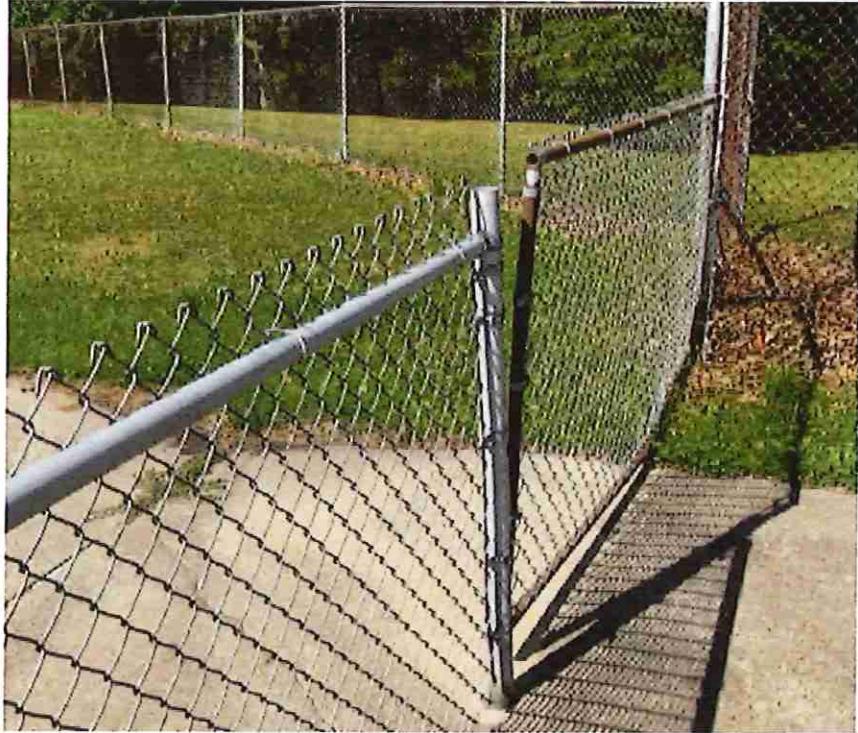
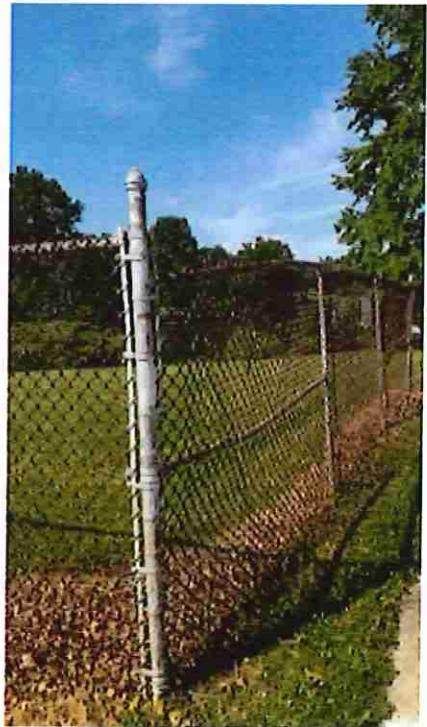
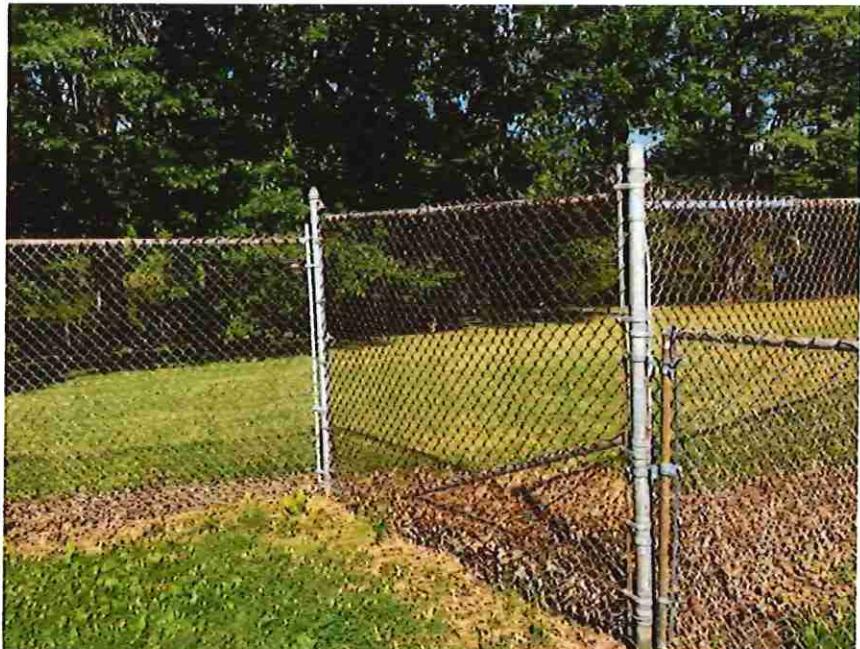
Rusted and bent fencing presents a hazard and results in gaps and openings in excess of the allowable 2-inch spacing.

Missing caps and end plugs allow water infiltration leading to further rusting. It also allows wasps to nest, creating additional risk.
