# Mill Pond Park Pool Evaluation

Town of Newington  
131 Cedar Street  
Newington, CT 06111

March 2013

## ***ENGINEERS REPORT***

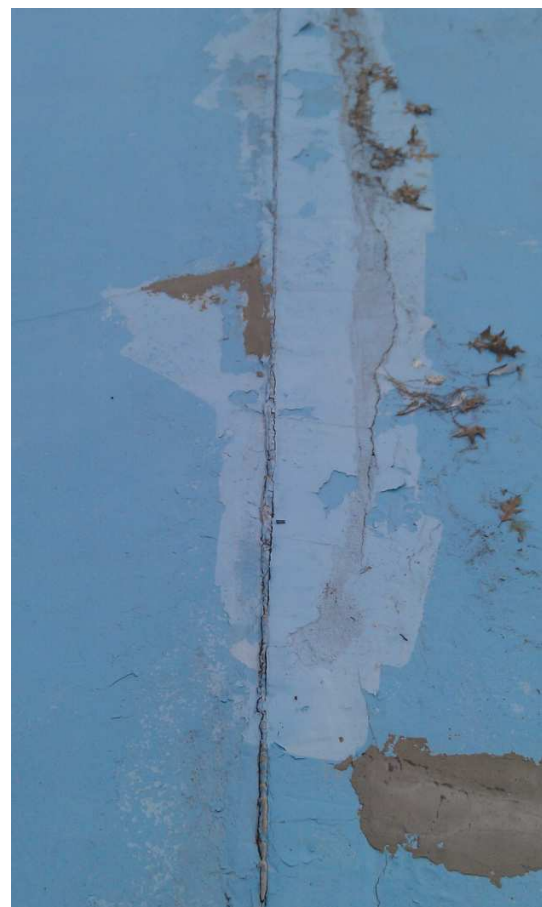
Figure 5 – Expansion joint, cracks, and patches

Mill Pond is located very close to the pool and water comes through cracks in the wall when the pool is drained. The static water pressure relief valve in the deep end has been cemented over. The static valve should be working correctly to allow water to enter the pool if the ground water table rises. The concrete pool floor is lightly reinforced and not designed to handle upward pressures due high ground water. The pool floors and walls have numerous cracks, and have been patched in various locations. (Figure 5) The expansion joints in the pool appear to be properly caulked.

A core sample of the concrete floor was taken in the shallow end of the pool (Appendix B). Compressive strength was found to be 6,850psi, which is good and means the pool shell is structurally sound. The soil beneath the floor appeared to be mostly clayish gravel. Clayish material is unsuitable for a structural base because it can result in movement that along with the static pressure will cause structural cracks.

- Option 1: Repair cracks in the pool walls with hydrophobic polyurethane grout crack injection. Replace all caulking and backer rod in expansion joints.
- Option 2: Install a new gunite pool inside the shell of the existing pool.
- Option 3: Remove the existing pool shell and install a completely new pool.
- Replace corroded valves, fittings, main pool pump, and corroded hardware.
- Replace the acid injection system with a CO<sub>2</sub> system.
- Install new chemical control equipment.
- Epoxy paint entire pool
- Replace depth markings.
- Replace concrete pool deck and sub base. Incorporate deck drains where needed.
- Replace diving board & stand.

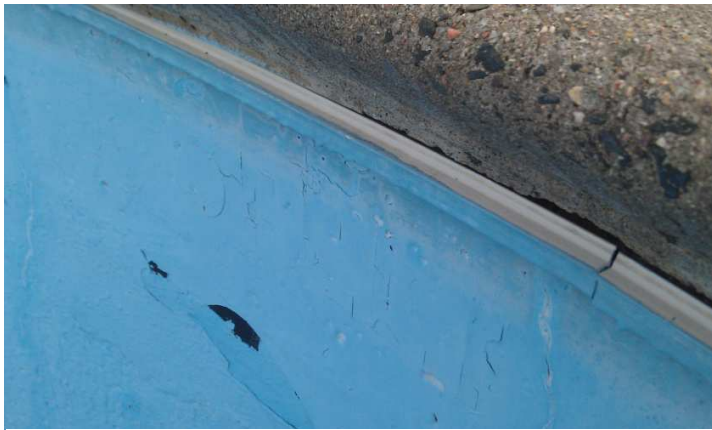
Figure 6 – Peeling paint and PVC joint separation

The pool operator plans to repaint the pool this year and stated that the concrete under the paint in some areas seems to be powdery and flakes off down to the aggregate. The paint is flaking and delaminating in many areas. The coping

strip at the top of the pool walls is coming out in places and may be a source of water loss. (Figure 6)

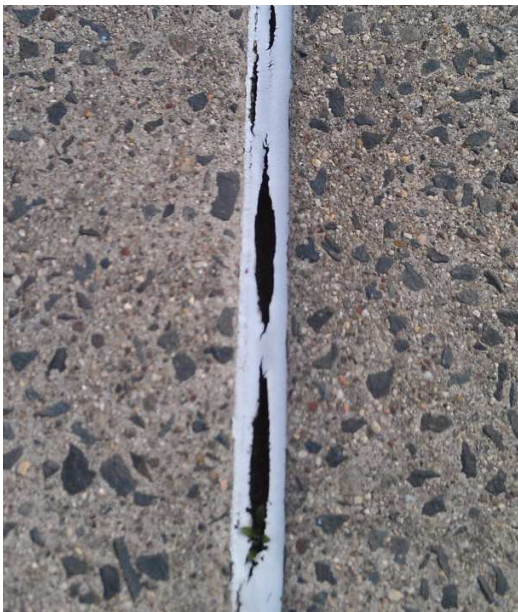
Figure 7 – Failed expansion joint caulking

The deck shows signs of settling and cracking in some areas that creates potential tripping hazard and can be uncomfortable and possibly cause an injury to bare feet. (Figure 8) Areas of the deck are discolored and some areas have been repaired. Overall the deck is not it too bad of shape for its age. Most of the caulking in the expansion joints on the decks is old brittle and cracked allowing for water to get beneath the deck and increase settling of the deck and the possibility of frost heaves. (Figure 7) Some of the expansion joints in the middle of the deck and the expansion joints between the deck and bathhouse are not sealed.

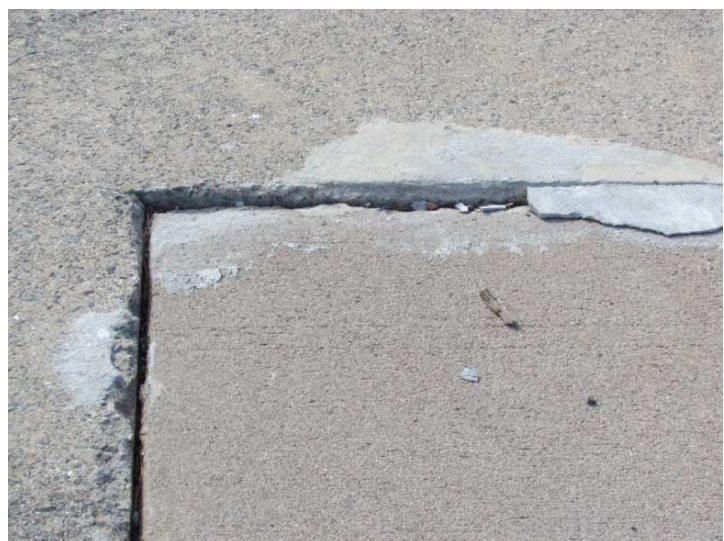
Figure 8 – Frost heave or settling concrete deck

The lack of a gutter or drain in the low spot between the bathhouse building and the pool has caused concrete deck separation. All water in this area is

draining through cracks and is saturating the soil under the deck. Water saturated soil can also put pressure on pool and foundation walls. The perimeter of the deck closest to the pool is newer than the rest of the deck. This portion of the deck was removed in 1999 when the piping was replaced. Rust is showing through the concrete deck in some areas. The welded wire mesh may have been installed too close to the surface.

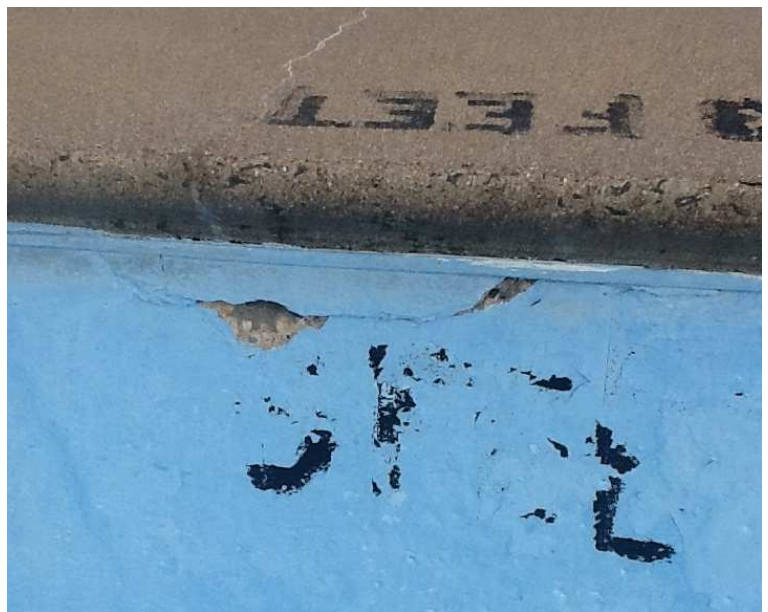
Figure 9 – Peeling depth markers

The depth markers on the pool walls and deck are hand painted or stickers. Most are faded or missing. (Figure 9) Some of the depth markers are incorrect. The depth must be measured from the floor of the pool to the water level. Depth markers must be provided on the pool rim at points of minimum and maximum depths, at all points where the pool floor changes slope, and at appropriate points in between. Depth markers at these points must be visible from within the pool and while standing on the pool deck. Letters and numbers must be at least 4-inches tall.

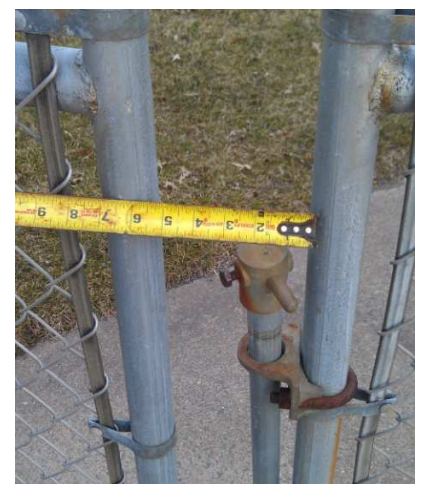
Figure 10 – Fence gate

The fence around the pool is galvanized, but is starting to show signs of rust. The fence is bent in some areas and has large gaps. The gaps between vertical members and between the ground and the bottom of the fence cannot be greater than 2-inches. (Figure 10)

- Repair gaps in fence, and secure loose fence areas.
- Review the inventory of lifesaving equipment and replace or supplement as necessary.
- Modify the main drain piping to keep water velocity flow rates under the rating on the Virginia Graeme Baker covers. This may conflict with CT pool guidelines, but is the only short-term solution.
- Remove the existing diving boards, and install smaller up to date boards that are compliant with the deep end dimensions.
- Replace depth markings.

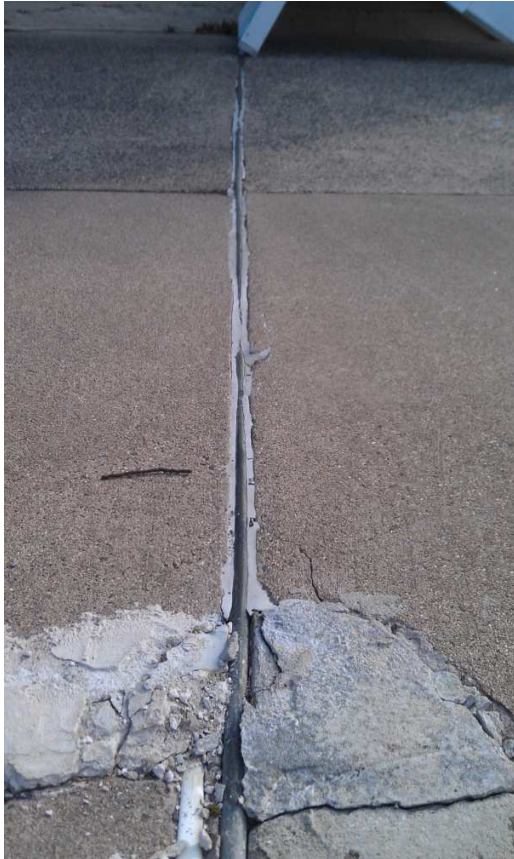
Figure 11 – Copper pipe for handicap lift

Pool staff reports new handicap lifts will be ordered for the upcoming season. The lifts will be hydraulic portable units, which need to be permanently anchored to meet ADA requirements (even though they are portable). This pool used to be equipped with a permanently mounted hydraulic (water powered) lift. The same connection can be used. The copper pipe connecting the lift was installed in an expansion joint in the concrete. The copper pipe is above the caulking and sticking out of the ground in areas. (Figure 11)

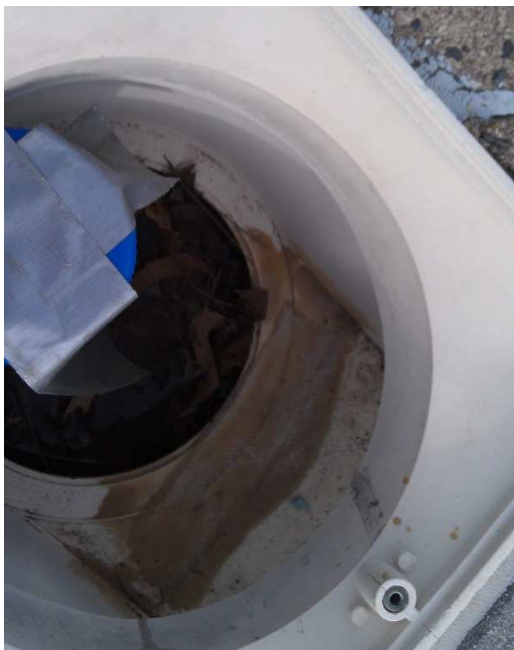
Figure 12 – Repaired skimmer

Many of the skimmers have stress cracks on the inside but have been repaired with fiberglass resin. (Figure 12) There are no skimmers along the deep end wall closest to

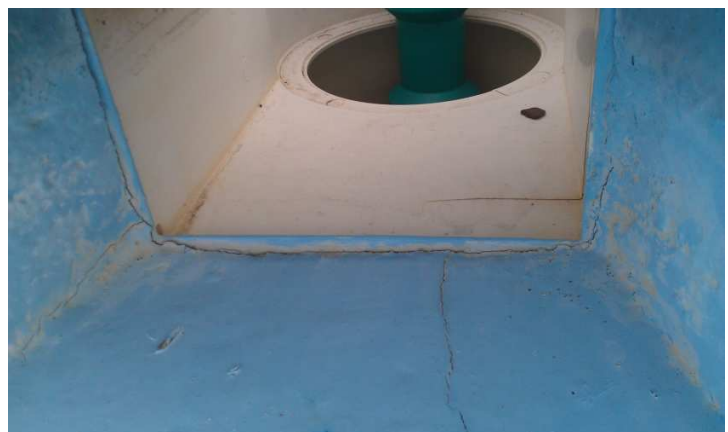
Figure 13 – Cracked joint between concrete and skimmer

the diving board. Skimmers are recommended in the deep end. The skimmers do not have equalization ports which are recommended by CT pool design guidelines. The skimmers appear to be cast in concrete with no caulking around the mouth of the skimmers. (Figure 13) The shrinkage between the skimmers and the concrete should be caulked to prevent water loss.

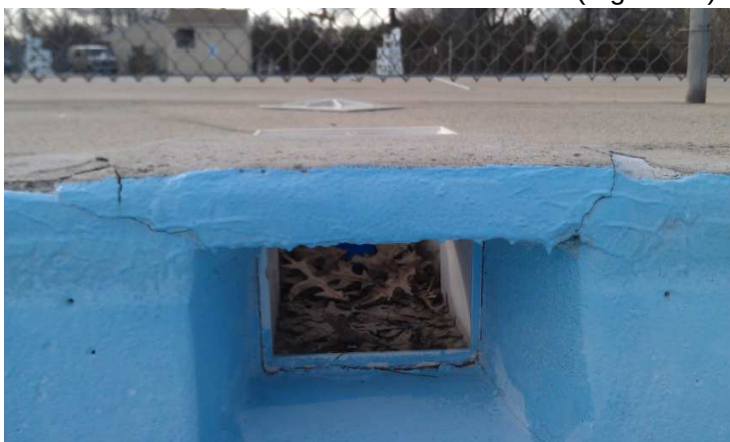
Figure 14 – Wading pool cracked coping above skimmer

The concrete coping is cracked in areas and has heaved around one of the skimmers. (Figure 14) The

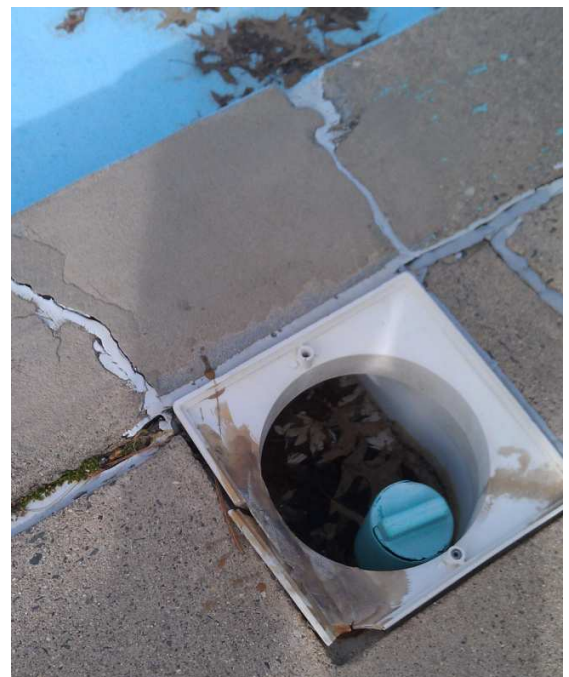
Figure 15 – Cracked skimmer and coping concrete

skimmers appear to be cast in concrete with no caulking around the mouth of the skimmers. The shrinkage between the skimmers and the concrete should be caulked. Some skimmers have cracked and have been repaired with fiberglass. (Figure 15)

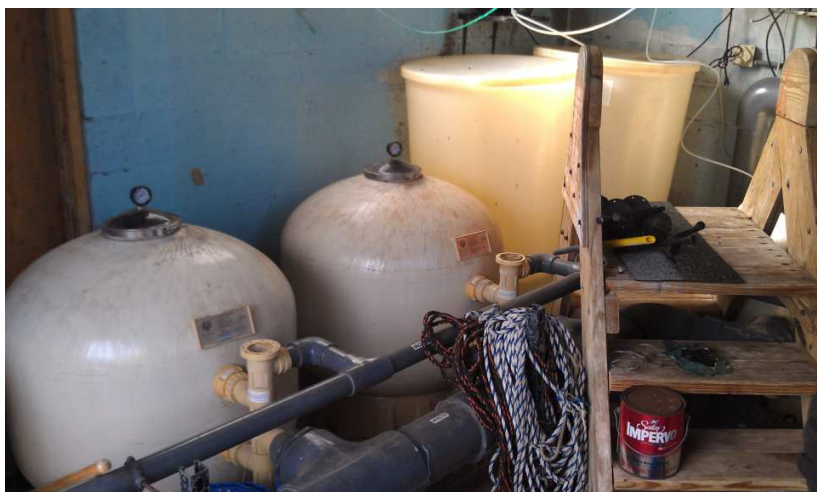
Figure 17 – Main pool filters, chemical storage, and stairs

An emergency eyewash station was present. Acid is used to lower pH. Carbon Dioxide (CO<sub>2</sub>) is much more commonly used than acid because it is less hazardous and is commonly available. Chemical tanks should have secondary containment in case of a leak. (Figure 17)

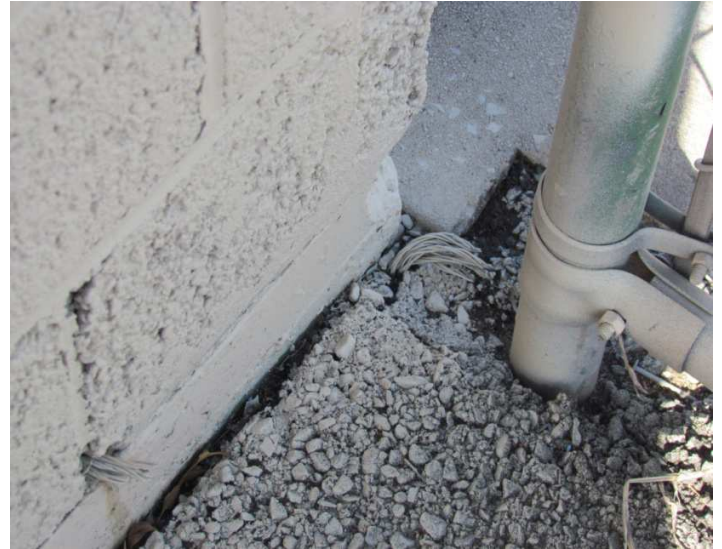
Figure 18 – Cut bonding or grounding wire

The existence of an electrical bonding grid around the pool is unknown, and probably non-existent. If major repairs are made metal deck equipment in the pool area and concrete reinforcement will need to be connected to a bonding grid. The bonding grid must connect to the pool pump. The pump is not bonded, and no bonding is shown on the plans. A wire just outside of the equipment room has been cut after it exits the building and before it enters the ground. (Figure 18) This wire may be either a ground wire or bonding wire.

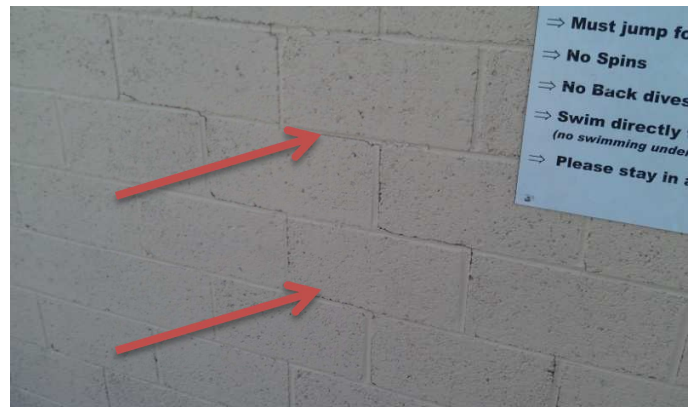
**Figure 22 – Traveling cracks on filter building**

The exterior CMU block walls on both buildings are painted. The masonry joints need to be caulked or repointed in numerous areas. There are a handful of holes in the CMU block on the outside of the building that should be filled with mortar or caulking. The holes may be from old piping or conduit. Some of the joints on the filter building show traveling cracks. (Figure 22)

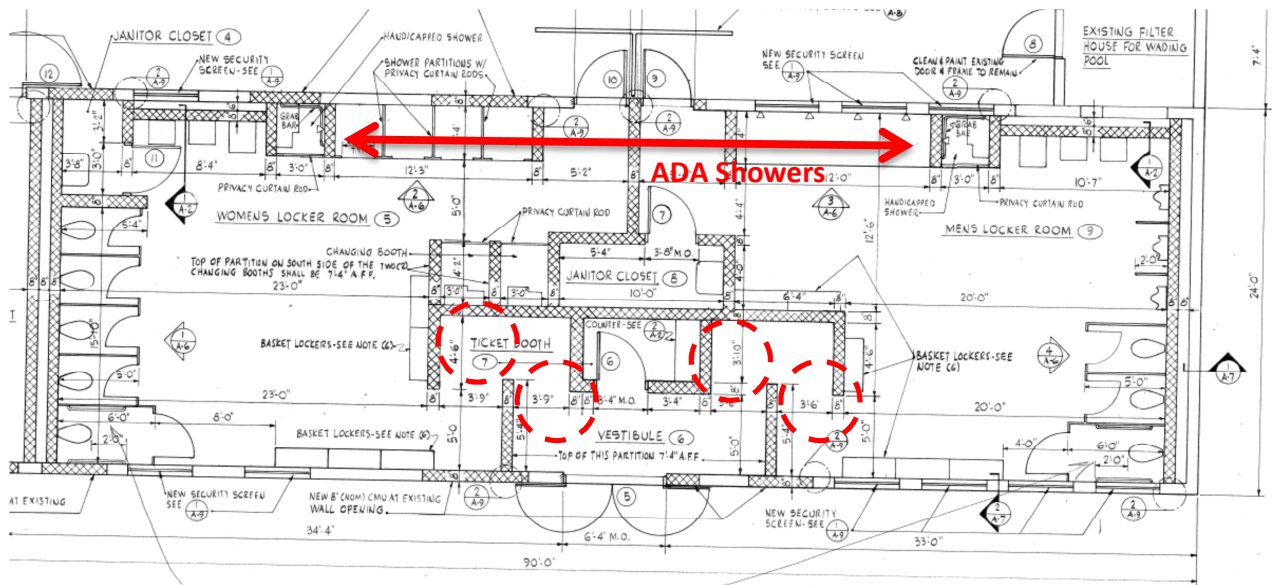
**Figure 25 – ADA issue areas (showers and insufficient turning radiuses)**

A clear 5' of width is required at all turning points for wheelchairs. (Figure 25)

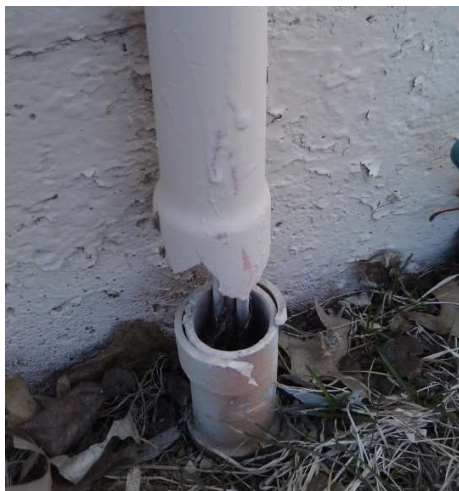
**Figure 26 – Conduit at rear of filter building**

The rear of the filter building has a snapped conduit with exposed wires (Figure 26). Conduit failure is common along foundation walls where conduit expansion joints are not installed, and the foundation has settled or heaved. The window glazing is cracked and in serious need of repair (Figure 27). The metal fascia and soffit on the bathhouse is falling out and missing in areas (Figure 28).

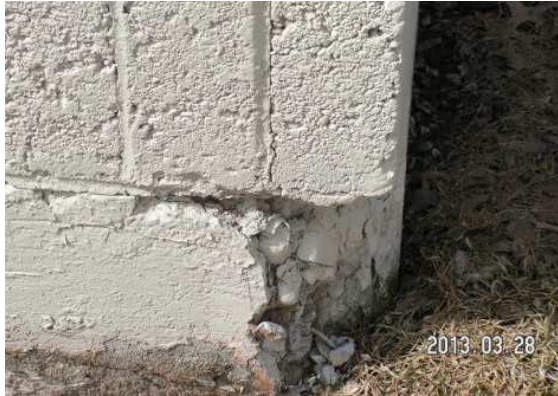
**Figure 31 – Foundation spalling**

The foundation is experiencing some cracking and spalling of concrete at the northeast corner of the building. (Figure 31) The threshold at the patron's entrance at the rear double door does not

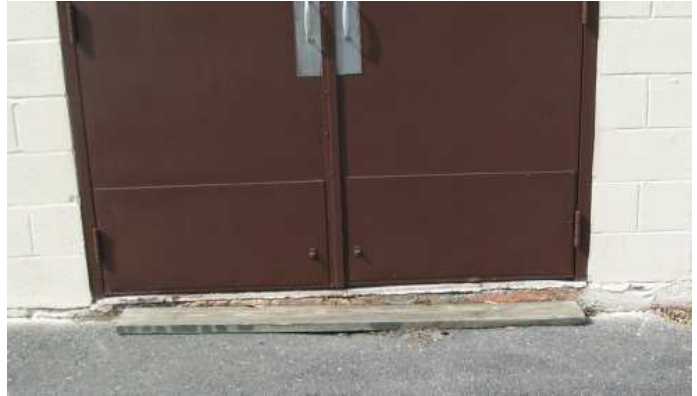
**Figure 32 – Bathhouse entrance trip hazard**

meet ADA due to the finish grade of the bituminous walkway. There is a loose 2x plank used to mitigate the change in elevation, which poses a tripping hazard. (Figure 32)
