TOWN OF NEWINGTON

AGENDA

April 26, 2016

Newington Town Hall Renovation Study

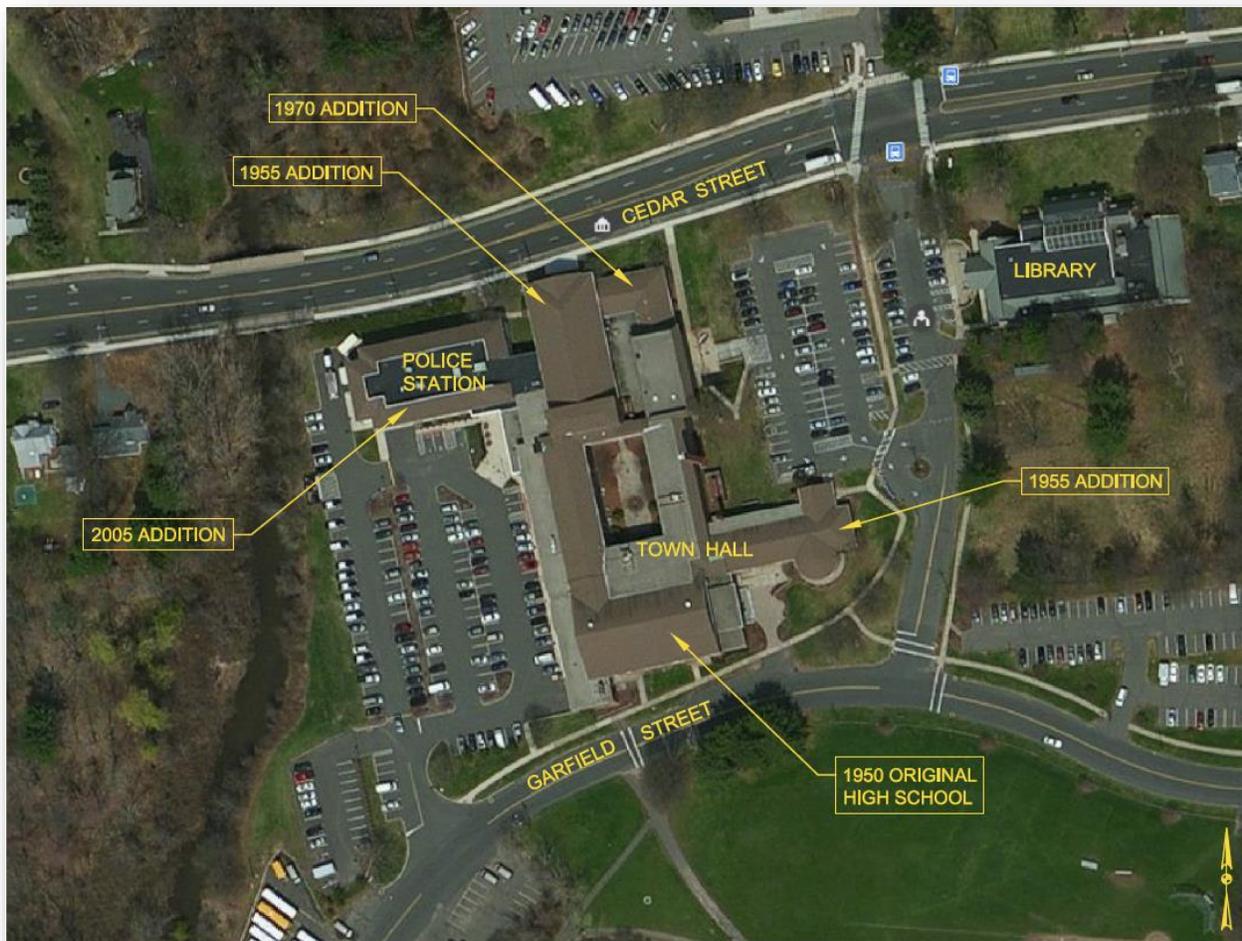
Parking is a major issue on site, and many residents are forced to park offsite and walk long distances. Additional parking is needed on site, although there is limited space currently to address this issue.

Directional signage guiding visitors to Town Hall is limited, as the official address is still Cedar Street. Individuals that are not familiar with the area may find it confusing. Access for handicapped individuals is good on the west side of the site. The parking drainage system is comprised of a network of catch basins within the roadways, parking area, and a few yard drains in landscaped area. The outfall is to the river. Generally the system functions adequately. (See the following overall site plan).

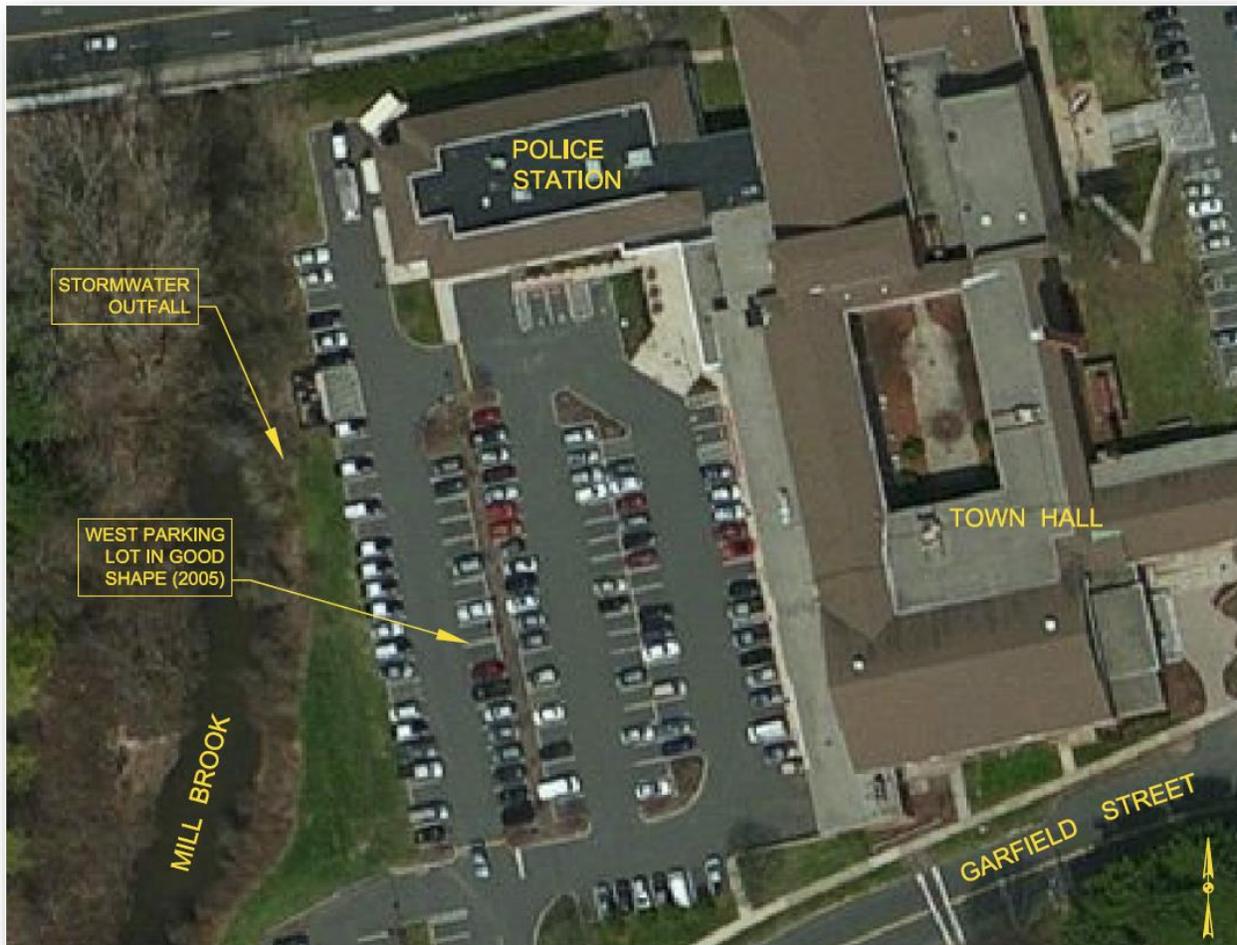
3.8.1 Western Parking Lot

The walkways and parking area on the west side were reconstructed when the Police facility addition (2005) was completed, and they are in excellent condition. Travel for pedestrians on the west side is good.

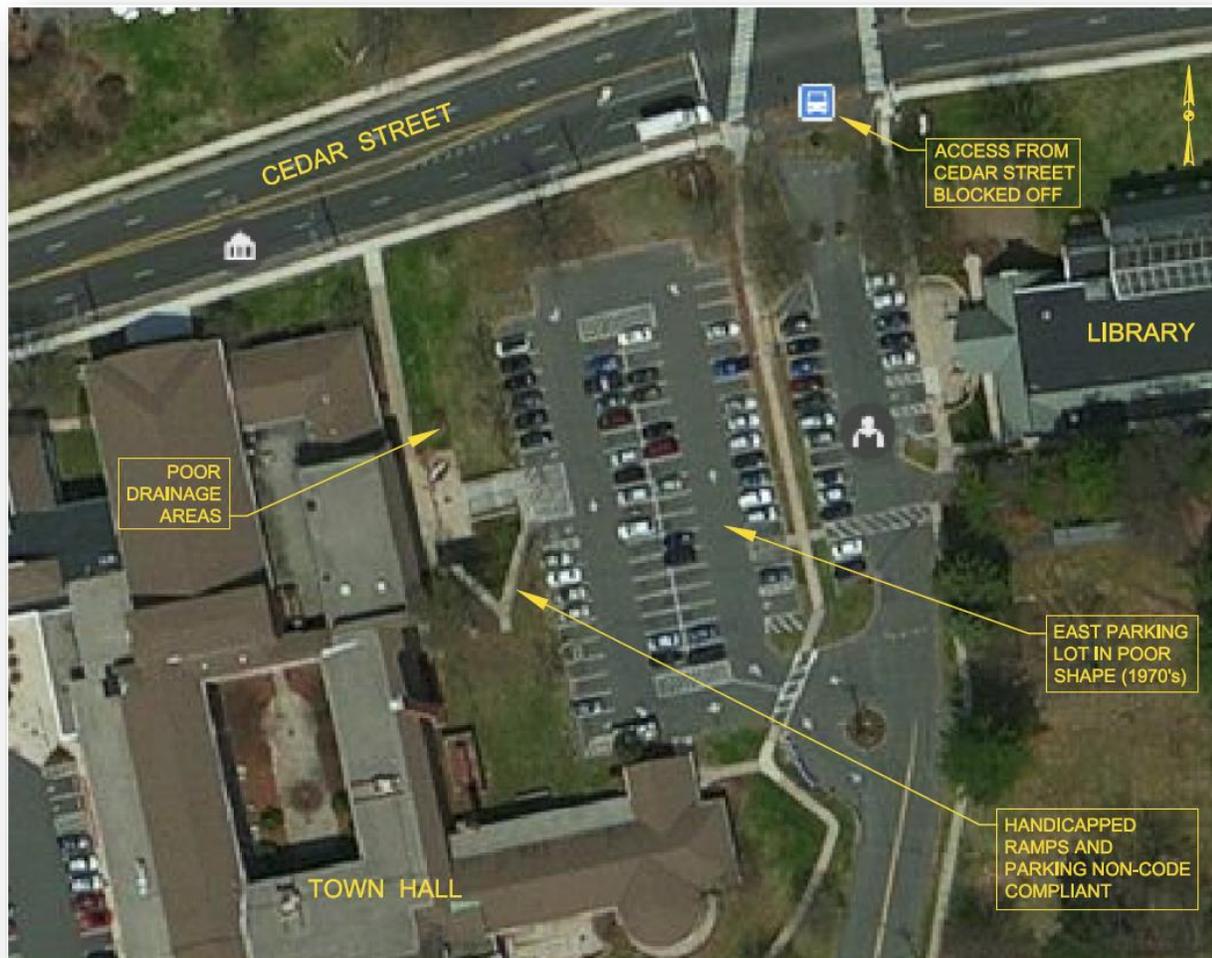
3.8.2 Eastern Parking Lot

The eastern parking lot dates to the 1970 construction and is in poor shape and should be reconstructed.

Travel for pedestrians is poor from the eastern lot with a set of stairs that are in extremely poor condition and a bituminous concrete ramp/walk that is also in relatively poor condition.

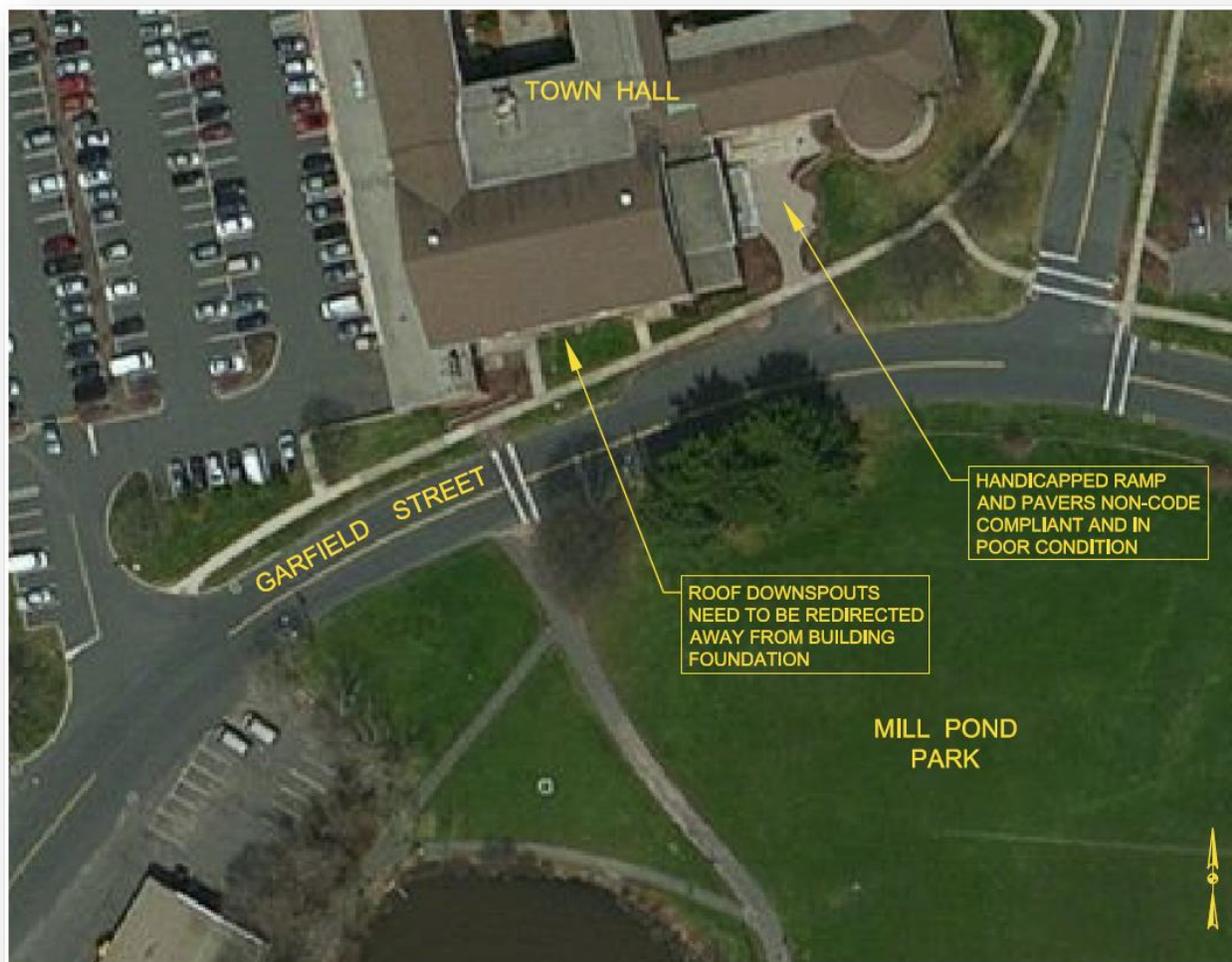
3.8.3 Southern/Garfield Street

Handicapped ramps on the south are poor and do not meet current standards. Downspouts do not appear to provide adequate drainage away from the building and runoff may be contributing to water issues in the building.

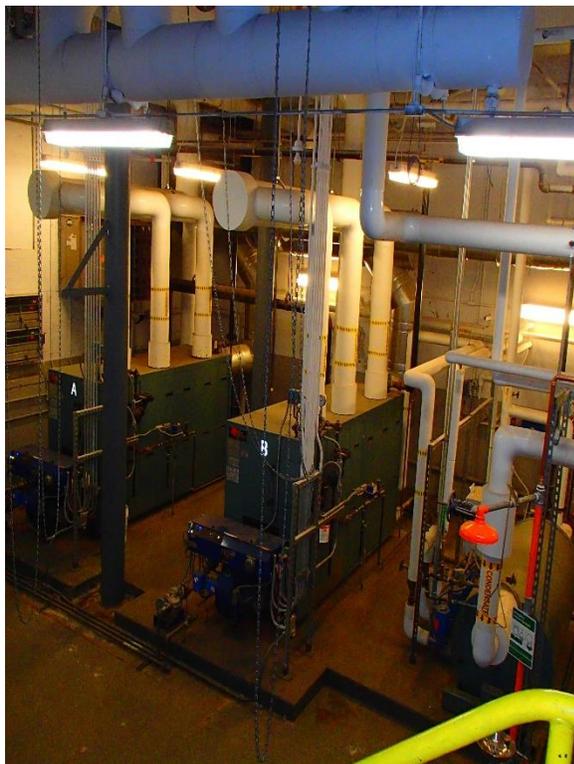
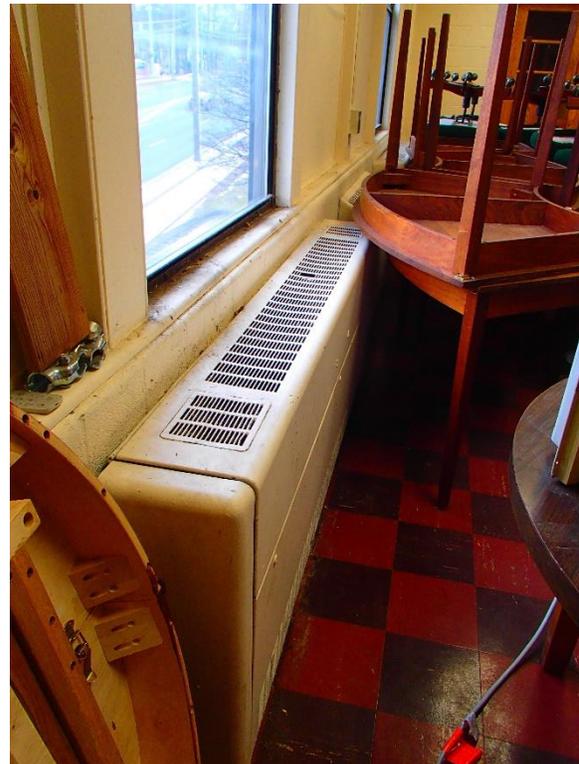
The heating plant includes two Smith Model 28HE-14 dual-fuel cast iron steam boilers that were installed in 2008, and are currently are in good condition. They each have a Net IBR output capacity of 2,769 MBH which equates to approximately 75% of the building's peak heating load, resulting in redundancy should one boiler require maintenance or repair. While these boilers are in good condition, the steam and condensate distribution piping is in very poor condition with leaks throughout the facility. Much of this piping dates back to the original construction of the building in 1950, and is currently in need of replacement. The steam systems feeds various air-handling units, fan-coil units, unit ventilators, convectors, and radiators. Due to the fact that the steam and condensate distribution piping must be replaced fairly soon, it is recommended that either the existing boiler plant be converted to hot water, or new high-efficiency hot water condensing boilers be installed. New boilers would result in significant operational cost savings.

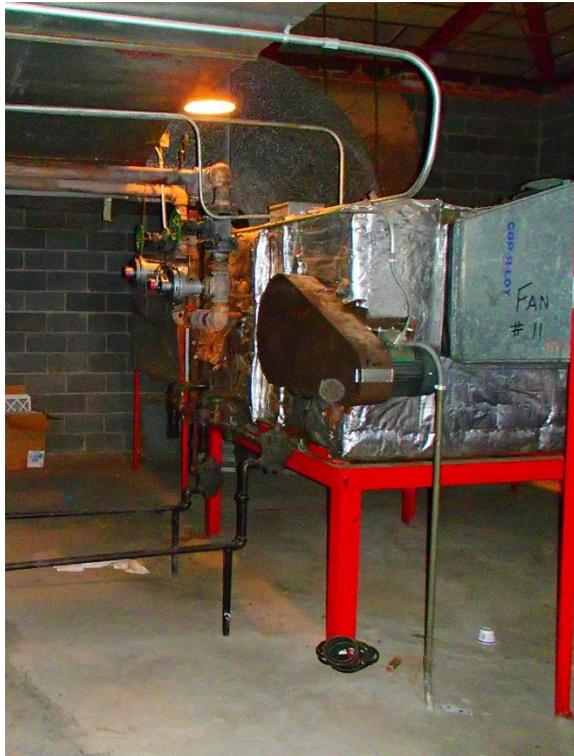
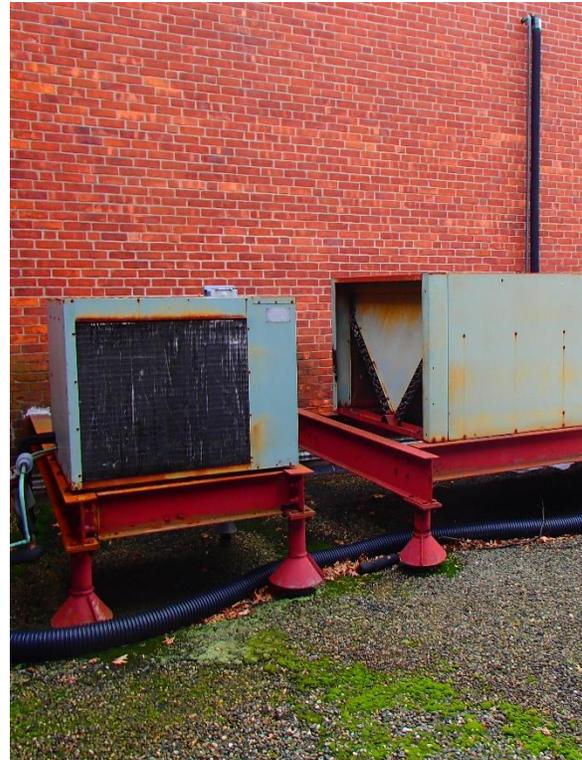
Split system air-handling units with steam heating and direct-expansion cooling serve some areas of the facility, including the Multi-Purpose Space, Town Council Chamber & adjacent offices, and the lobby & adjacent interior spaces. Associated condensing units are located either on the roof or at grade, generally nearby to the air-handling units. This equipment was installed in the 1950's, the 1970's, or the 1980's. Based on the age and appearance of these systems, replacement is recommend.

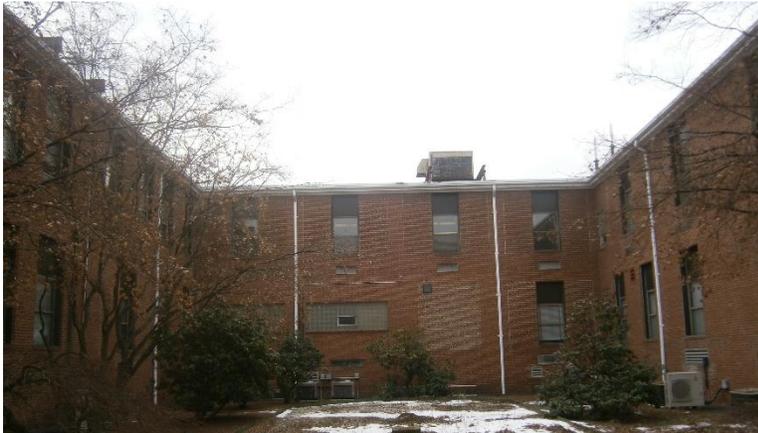
Two packaged rooftop units that were installed in the 1970's serve interior portions of the Second Floor. Based on the age and appearance of these units, replacement is recommend.

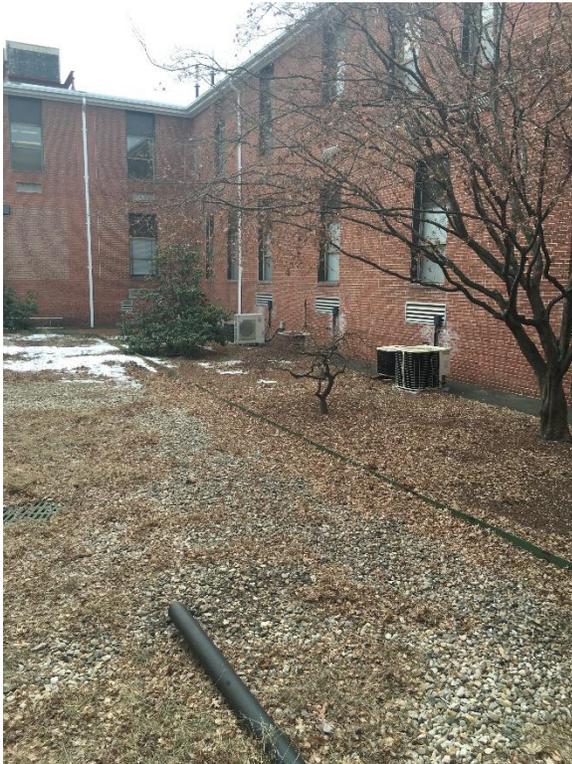
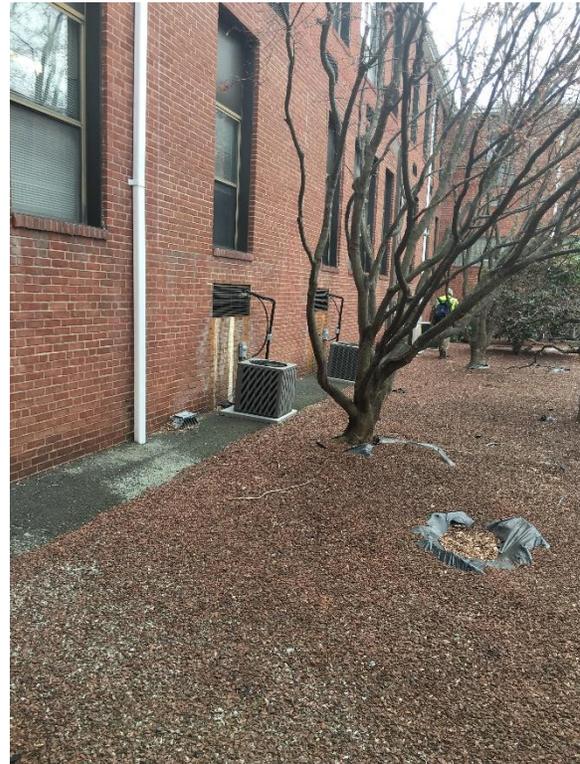
Through-the-wall air conditioning units and unit ventilators installed in the early 1970's serve or previously served many of the office areas throughout the facility. As many of these systems have failed over the years, small independent fan-coil units and split systems have been installed, with the associated condensing units located in the courtyard, on grade outside the building, or on the roof. These numerous independent small split systems are inefficient, do not often provide mechanical ventilation, and the number of systems creates increased maintenance costs.

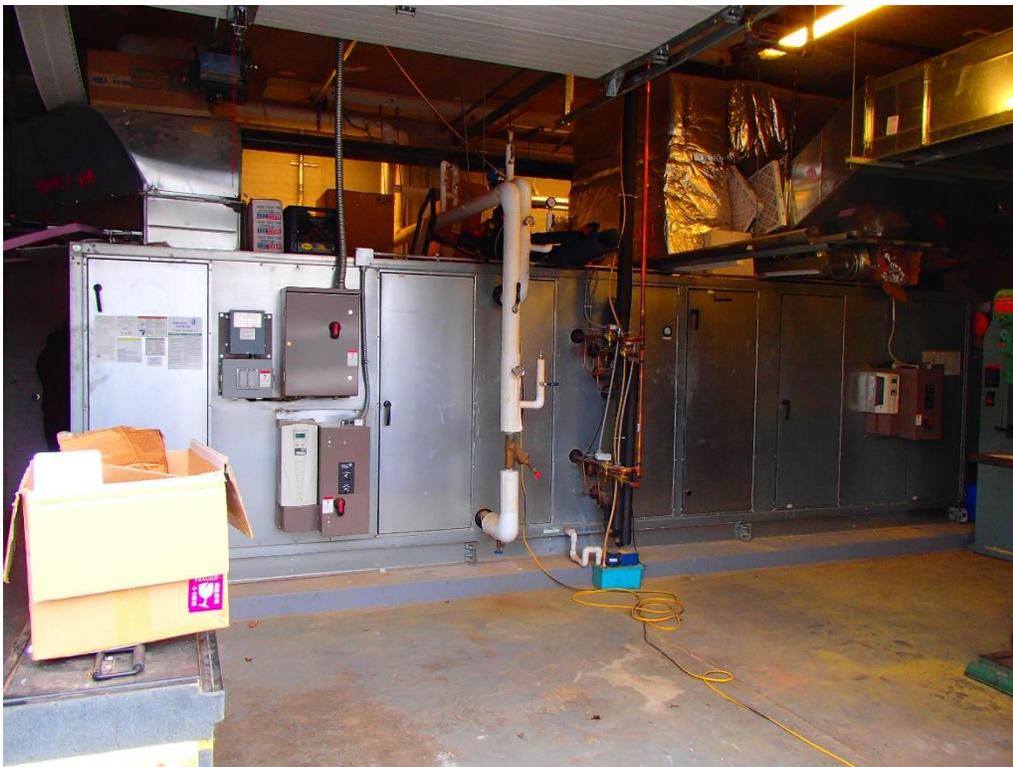
Two areas of the building were renovated in 2009, and new HVAC systems were installed. The Lower Level is served by a variable air volume air-handling unit with hot water heating and direct expansion cooling, a condensing unit located outdoors. Zones served by this air-handling unit include VAV boxes with hot water reheat, and perimeter hot-water baseboard radiation to provide independent control of each zone. The First Floor of the East Wing is served by a similar system. The hot water for these two systems are provided by a steam-to-hot water heat exchanger located in the boiler room. At this time, there is no reason to replace these two systems.

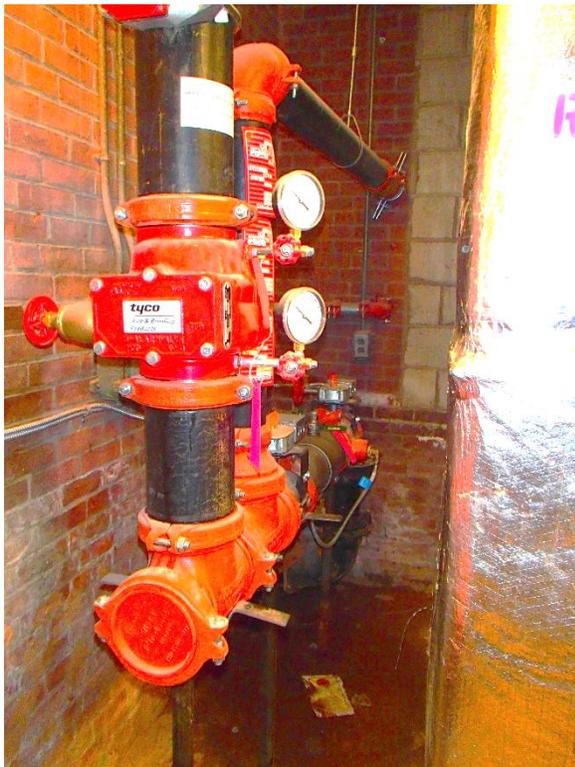
Sprinkler System Riser - Wet System

Two sprinkler services and rooms exist. One is a six-inch wet system and another is a six-inch dry system. A backflow preventer was not located for the dry system.

The sprinkler systems as installed are newer and in good condition. It is desired to fully sprinkler the remainder of the building.

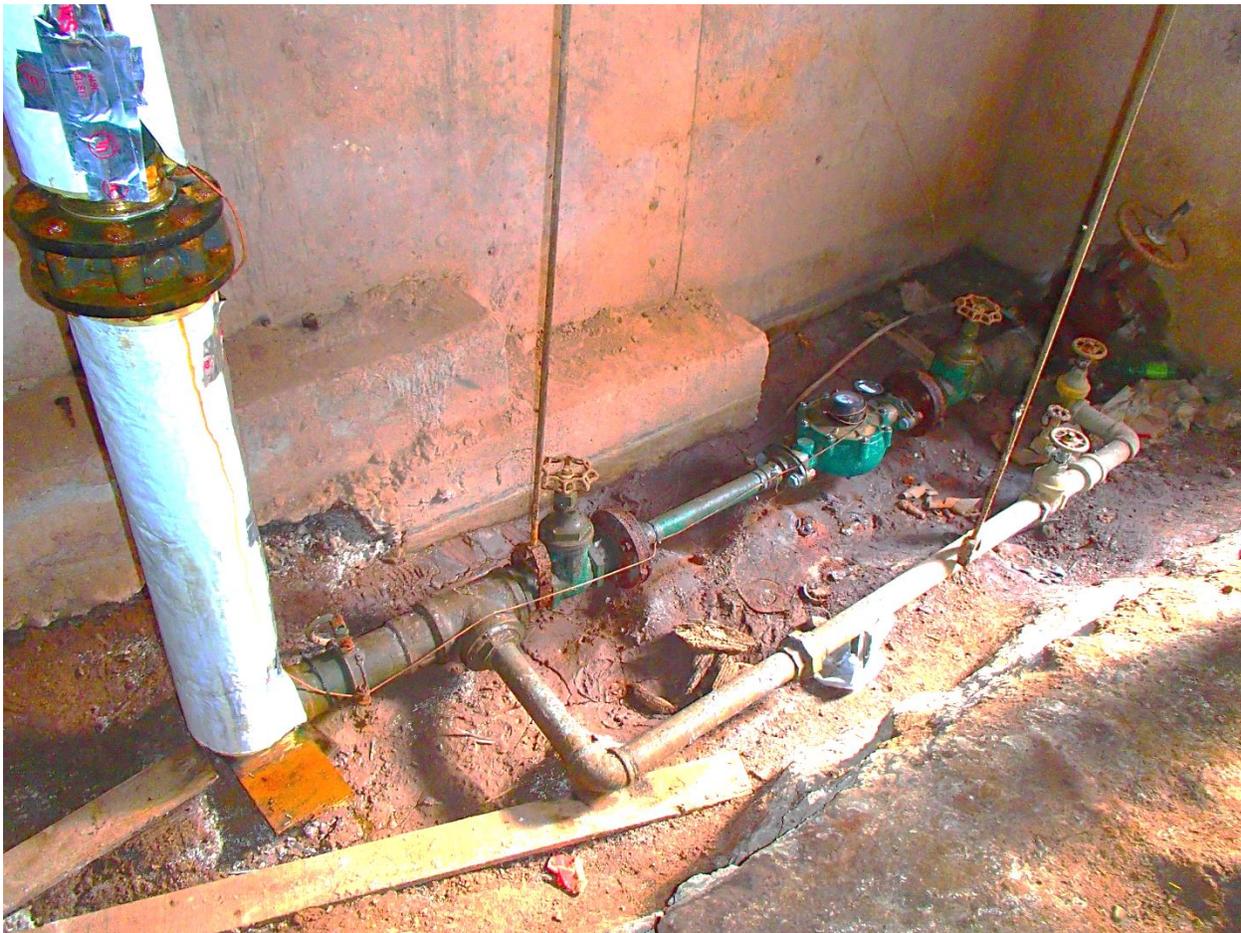
Water pressure is very good; 95 psi static. Water pressure greater than 80-psi is required to be reduced with a PRV valve. Water piping is copper tube with leaded solder joints. The water service is a public supply with a 3" main and meter entering a dirt crawl space under the gymnasium. The pipe is heat traced if there is a freeze up. There is no backflow preventer and the service is severely corroded due to the high moisture environment from the steam piping. It is recommended to remove and replace all water piping in the pipe tunnels.

- Replace ejector pump in boiler room, see attached cut sheet for pricing purposes
 - Replace severely corroded water piping in pipe tunnels, Copper tubing with soldered joints

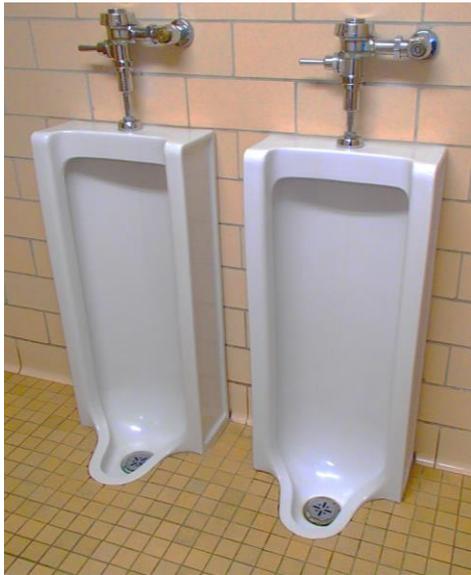
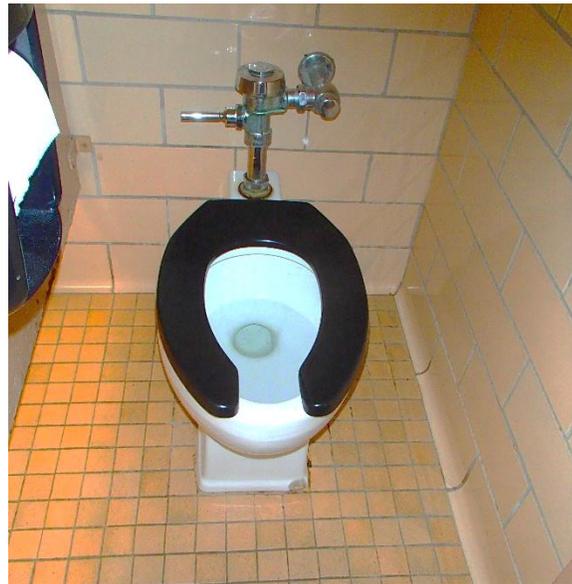
Plumbing fixtures are original except for the small renovated areas, as a result they are not ADA accessible, not energy efficient, not NSF and made with lead parts. It is recommended to remove and replace all the plumbing fixtures with new.

- Replace all plumbing fixtures with new, Kohler fixtures or equal with manual flush valves
 - Provide new ADA fixtures where required, Kohler fixtures with manual flush valves

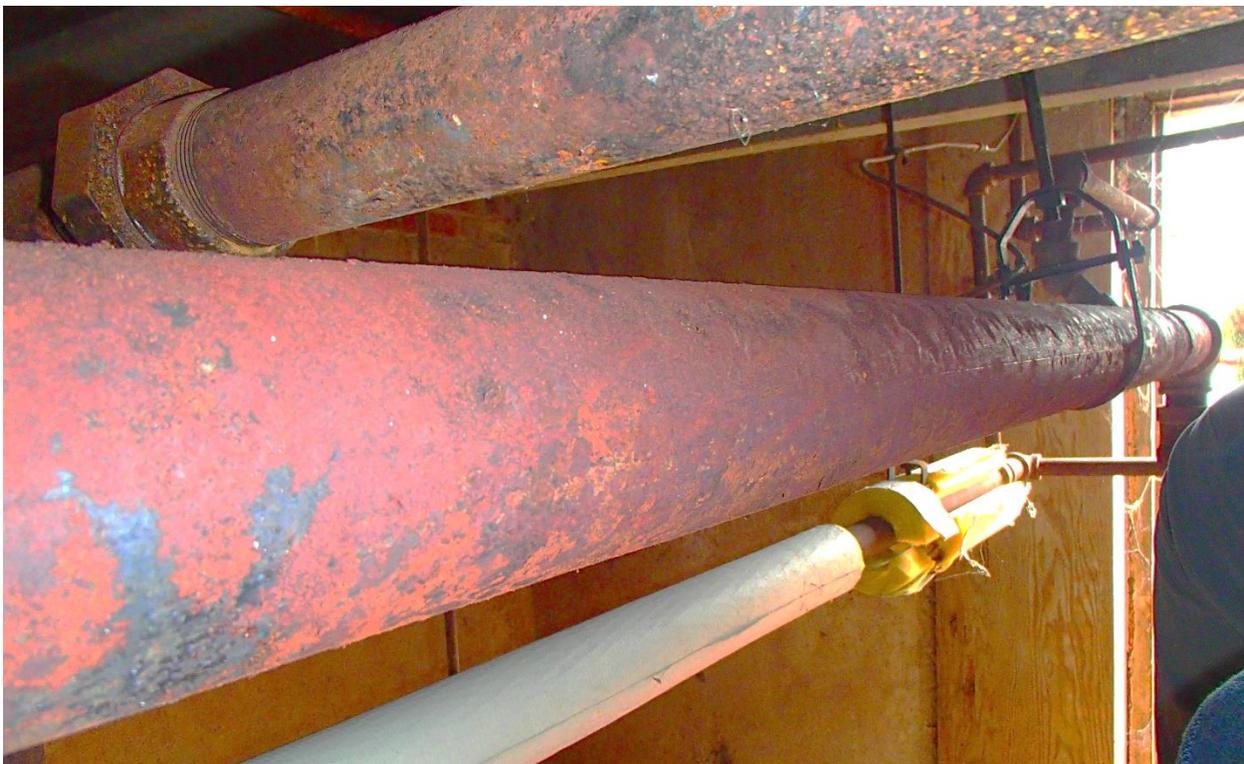
Sanitary sewer exits the rear of the building to a site sewer system. The majority of the piping is original, cast iron and up to 66 years old and past its life expectancy. The piping has had a major failure recently in the pipe tunnels which incurred a replacement and cleanup cost of \$100,000. The steam piping and high moisture in the tunnels is causing severe corrosion due to the environment. It is recommended to remove and replace all the sanitary, waste and vent piping.

- Plumbing
 - Re-use existing sanitary main from building
 - Re-use existing domestic water service to building
 - Replace all existing sanitary piping in building with new except Transition Academy and Lower Level Reno Areas, PVC schedule 40 piping. Sanitary main in pipe tunnel was recently replaced and will remain.

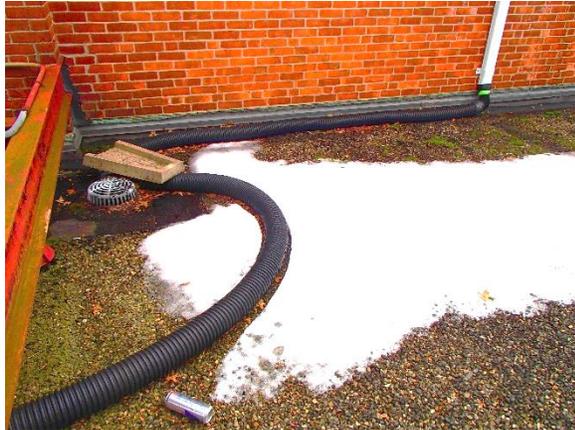
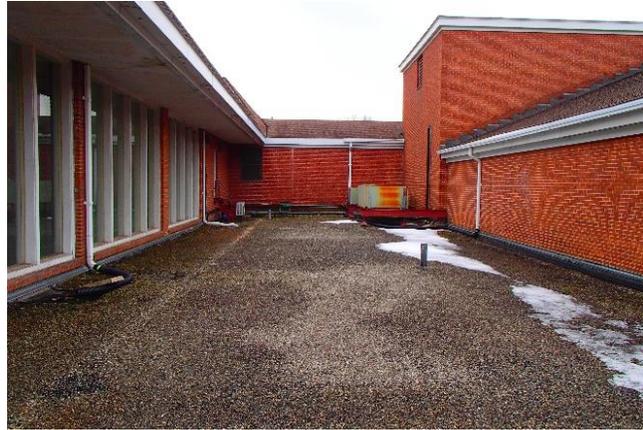
Some plumbing vents are located too close to mechanical unit intakes. They were retrofitted and raised approximately eight feet to help prevent sewer gases from entering the units.

Roof drains were minimal as the majority of the roof is pitched to exterior gutters and downspouts. The flat areas have roof drains but the roofing membrane is severely deteriorated that the rain water does not readily flow to the roof drains and ponding occurs. There is no secondary drainage system as required by current code. If the primary system gets clogged or fails, a roof failure could occur. It is recommended that these areas be removed and replaced and brought up to current code.

- Majority of roof drains are exterior architectural gutters and downspouts
 - Replace and re-pipe roof drains for minimal flat areas, PVC schedule 40 piping

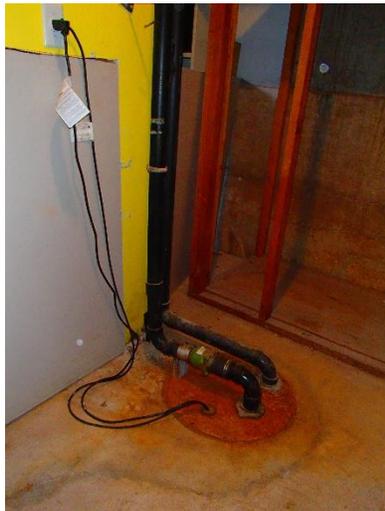
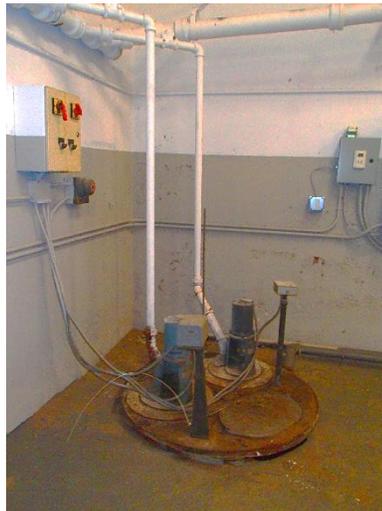
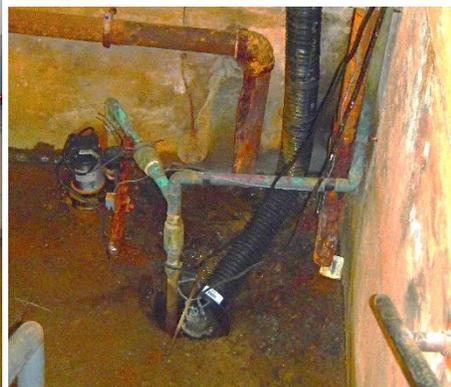
Sump pumps are located in pipe tunnels and basement areas. Some of these pumps are original to the building, well past their life expectancy and should be replaced.

- Provide new overflow drains for minimal flat areas, Froet bifunctional type
 - Existing water heaters are newer to remain
 - Replace ground water pump in tunnel near boiler room, see attached cut sheet for pricing purposes

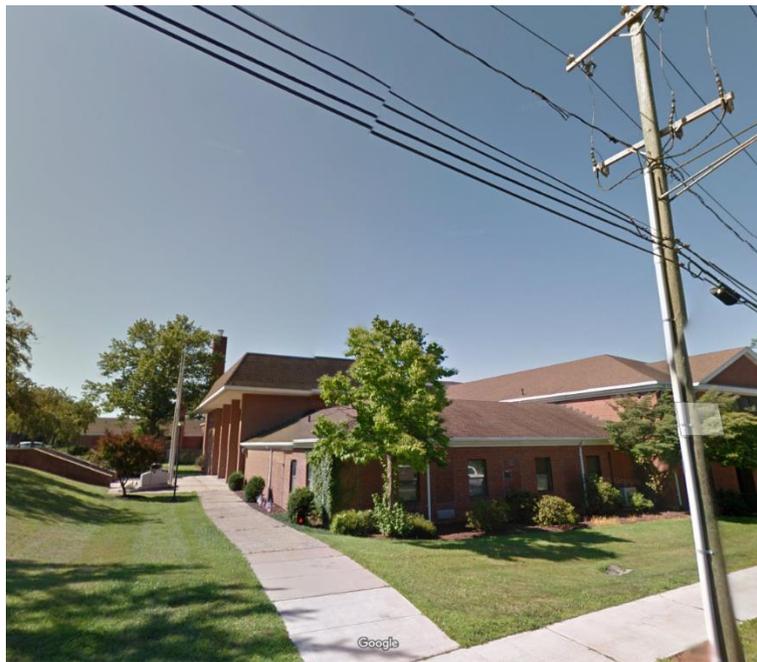
Electrical Service Pole

The existing electrical service to the building is routed via an overhead high voltage pole line beginning along Cedar Street, continuing around the east side of the building and eventually in to a transformer vault in the building. From the transformer, the secondary (service) conductors route through a wall into the back of the existing main electrical service switchboard that serves the whole building. The overhead lines and vault transformer are owned by the utility company. In current times, the utility company does not allow transformer vaults – all new transformers of this size are required to be located outside the building on a pad. Transformer vaults present more risk of fire damage to the building as compared to a pad mounted transformer.

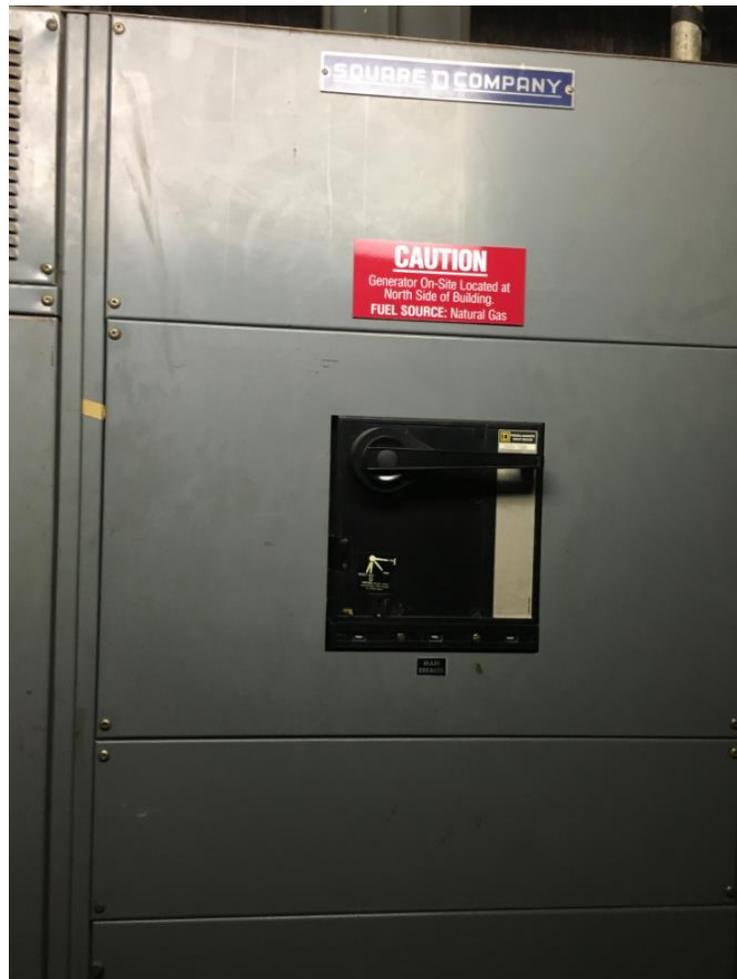
Existing Main Service Breaker

The main switchboard (1600A, 208Y/120V) is over 40 years old, contains original circuit breakers and is in need of replacement due to age and reliability. Older electrical equipment may not trip breakers when needed, causing fire hazard concerns. Modern switchboards contain more reliable digital trip circuit breaker, do not require fuse replacement after faults, and have readily available replacement parts. It is recommended that the electrical switchboard be replaced with modern digital trip circuit breakers, ground fault protection and surge suppression for reliability and safety of the electrical system.

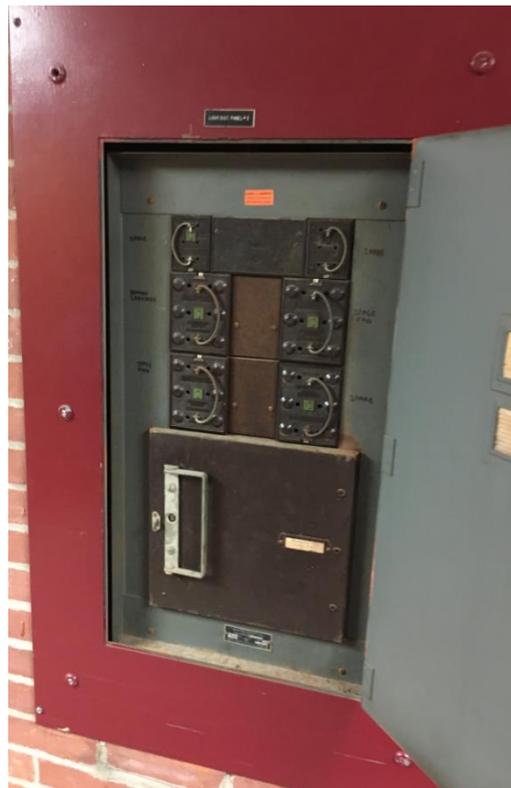
Example of Old Electrical Panel

From the switchboard, power is distributed through a multitude of panelboards located throughout the building. The majority of this equipment is also over 40 years old and should be replaced due to age and reliability. Many panels also contain fuses, and are likely over 60 years old. Many existing panelboards are also full, which decreases ease of adding new electrical circuits as they are needed. DTC was not able to observe wiring methods within the walls and above ceilings, but due to age it is assumed cloth wiring is present in the building, which presents fire safety concerns.

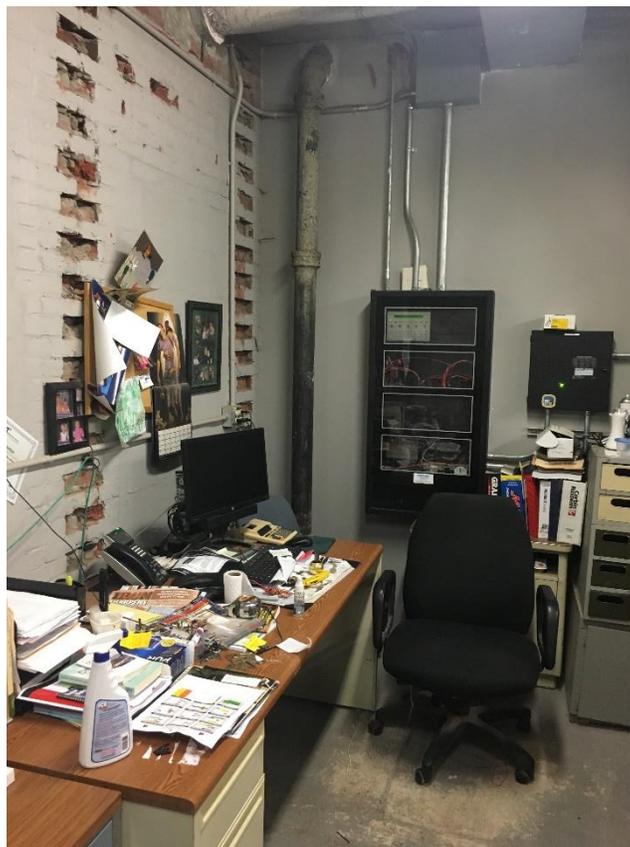
Existing Fire Alarm Control Panel

The fire alarm control panel is manufactured by Notifier, is addressable, expandable and is not in immediate need of replacement. Many of the fire alarm devices throughout the building appear to be non-addressable devices that should be upgraded to addressable for additional fire safety. The placement and quantity of fire alarm devices around the building do not meet code in many places. Many of the exterior doors do not have pull stations and many of the rooms do not have adequate audio/visual coverage per current NFPA requirements. Smoke detectors should be added to all electrical, IT and storage rooms. Some critical document storage areas do not have adequate smoke detection coverage, which is quite risky. Voice evacuation should be provided in all areas of assembly. As such, it is recommended that new addressable devices be provided throughout the building, and connected to the existing (Expandable) fire alarm control panel per current NFPA requirements. This will increase fire safety within the building, and will improve fire department response

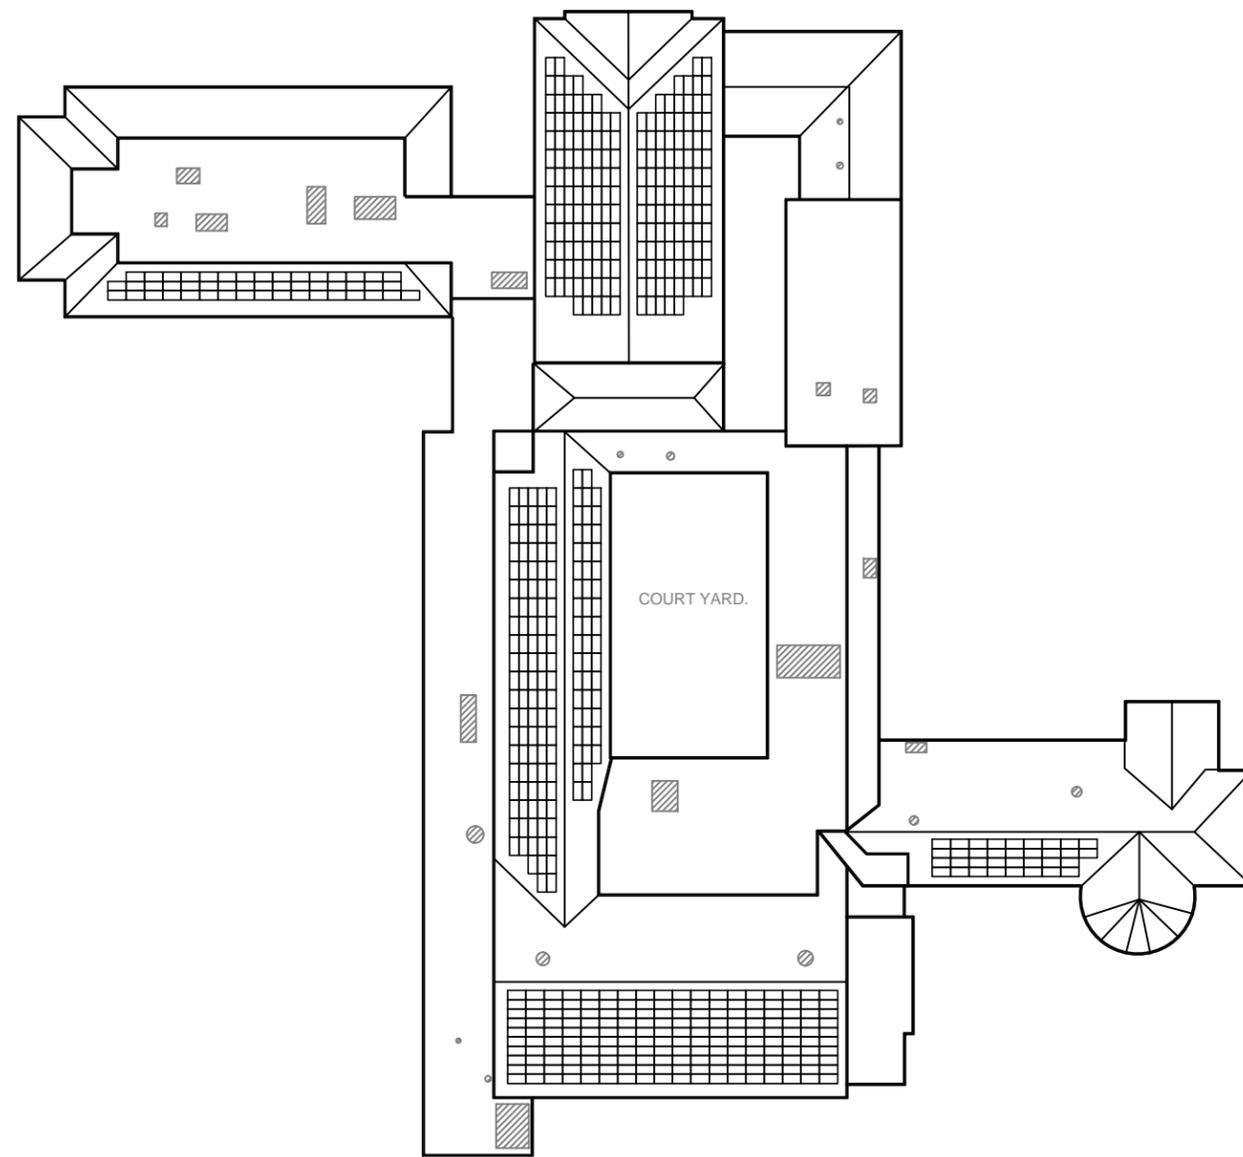
SYSTEM INFORMATION	
SIZE DC	192.78 KW DC
SIZE AC	138.0 KW AC
PANEL TYPE	JAP6 72-315 3BB
PANEL QUANTITY	612
INVERTER TYPE	SOLECTRIA PVI 23TL
INVERTER QUANTITY	6
1 YEAR PRODUCTION	xxx MWH/YEAR

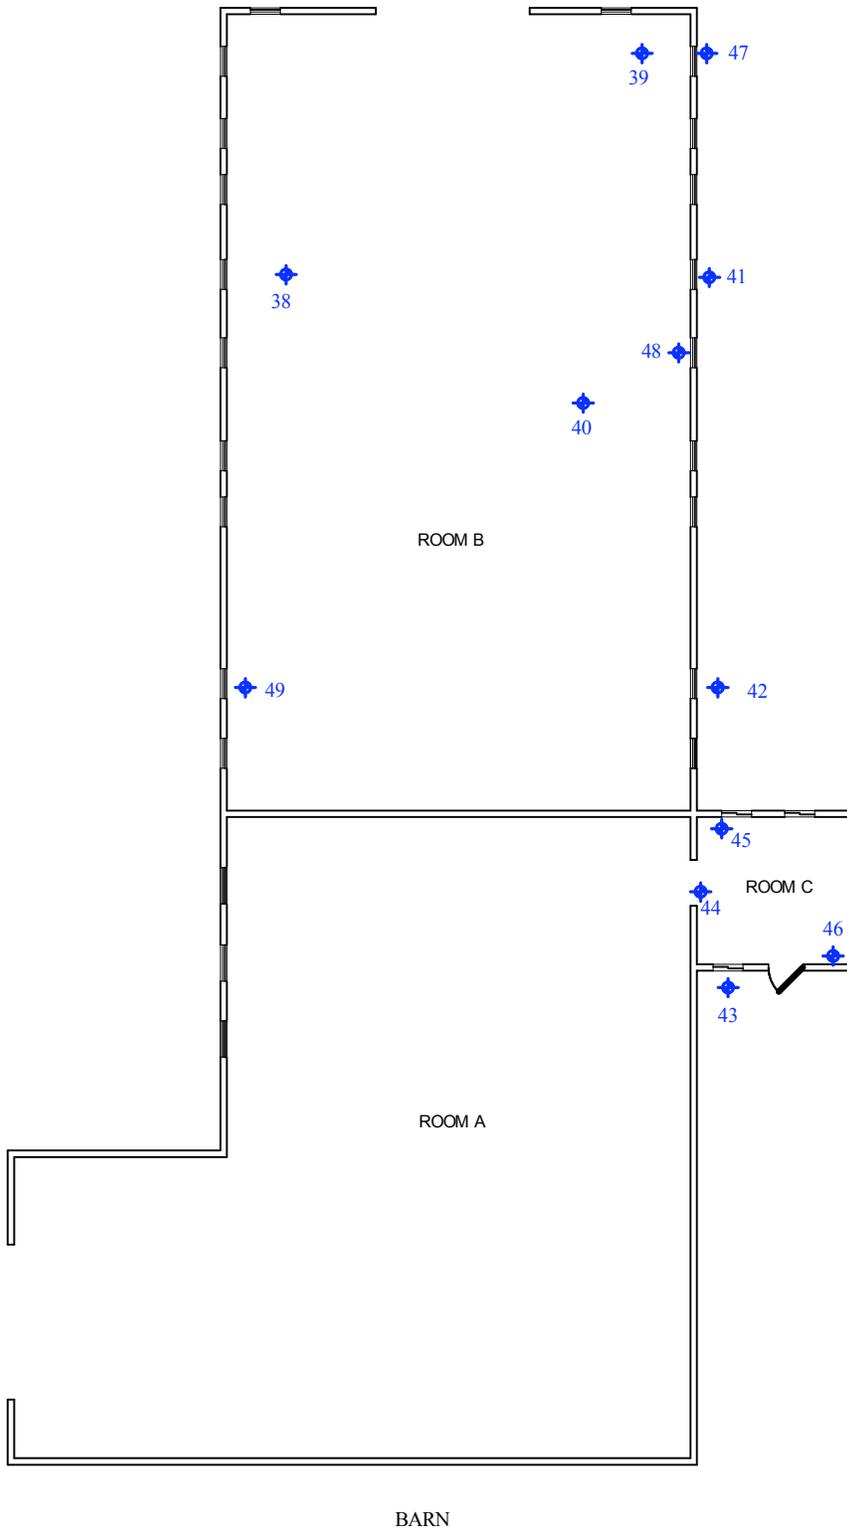
The following materials in areas tested were found to have no asbestos detected that include: gray roof shingle, black roof shingle, black roll on roofing felt, black roof cement, black roof sealer, thick layer black roofing cement, orange siding shingle, red siding shingle type 1, red siding shingle type 2, red siding shingle type 3, brown siding repair shingle, textured ceiling compound, window glazing, window sill brown tar sealer, black siding tar.

Drawing Title: Asbestos Inspection Location Diagram		Date: 02 / 17 / 2016
Project: Deming Young Farm 282 Church Street Newington CT		Scale : NTS
Prepared For: Town of Newington		Drawn By : TN
Prepared By: EnviroMed Services, Inc. 470 Murdock Ave , Meriden CT		Drawing No. ASB-1
Project No. IH-16-045
