## I. Introduction

Owens Realty Services has been retained to provide consulting services to provide a conditions assessment, inclusive of a visual inspection and Code compliance review of the outdoor swimming pools at Mill Pond Park.

## II. Executive Summary

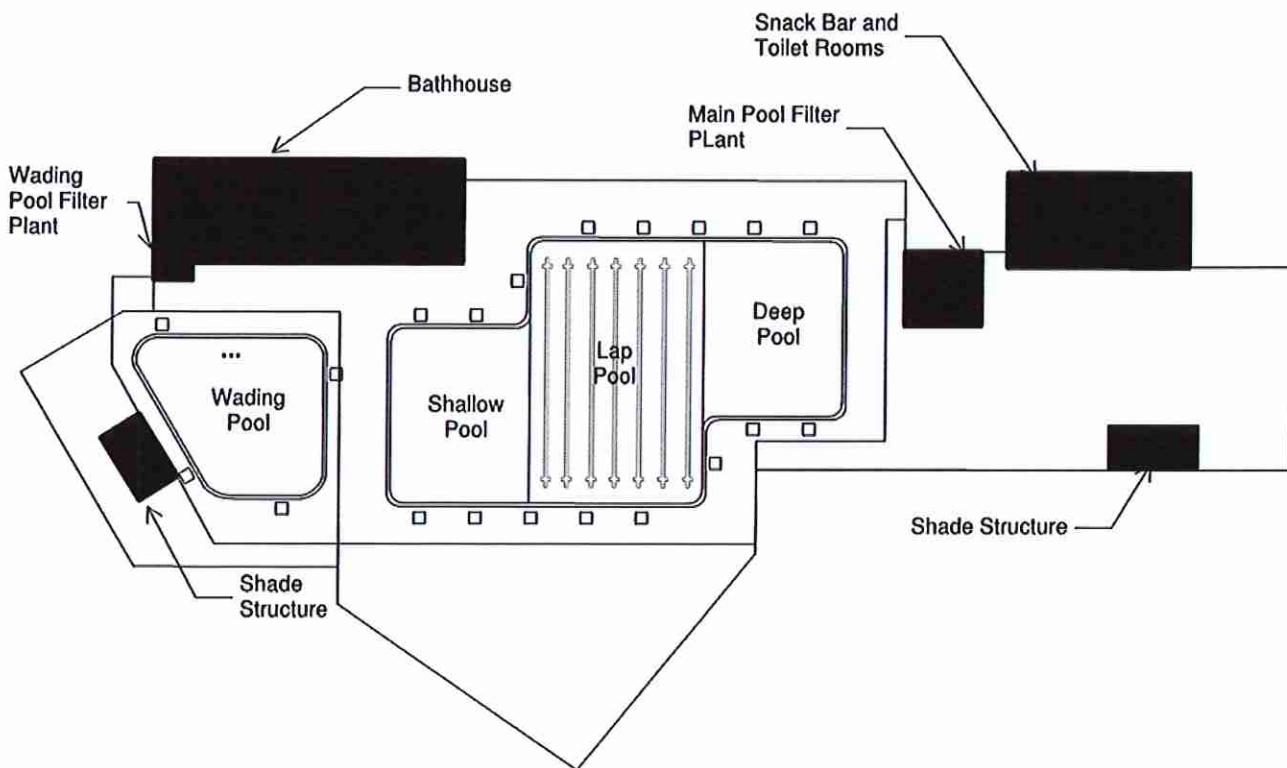
The pool perimeter is surrounded by a six-feet high, galvanized chain-link fence, with the portion separating the wading pool from the main pool standing 4-feet high. This outer perimeter fence provides a complete enclosure, using the bathhouse and filter building as a portion of the enclosure. It is in poor condition with significant rusting, misalignment and gaps exceeding allowable dimensions, both between posts and to grade below the fencing.

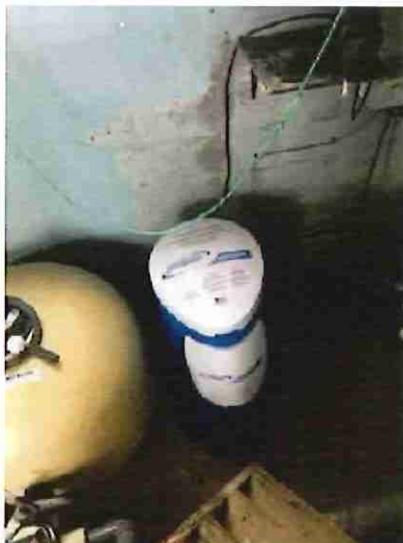
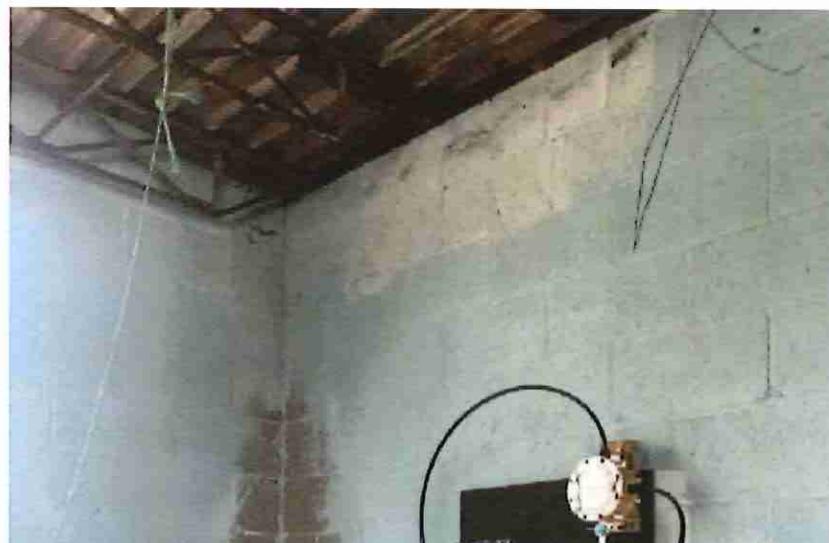
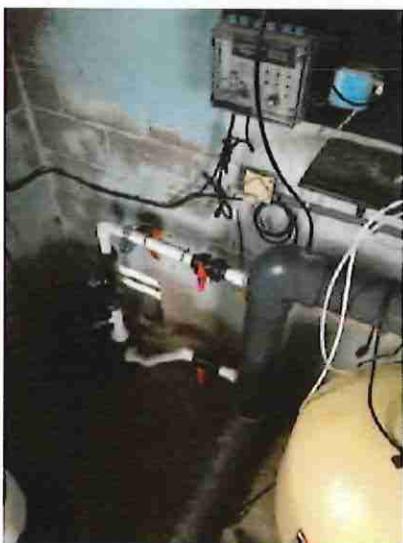
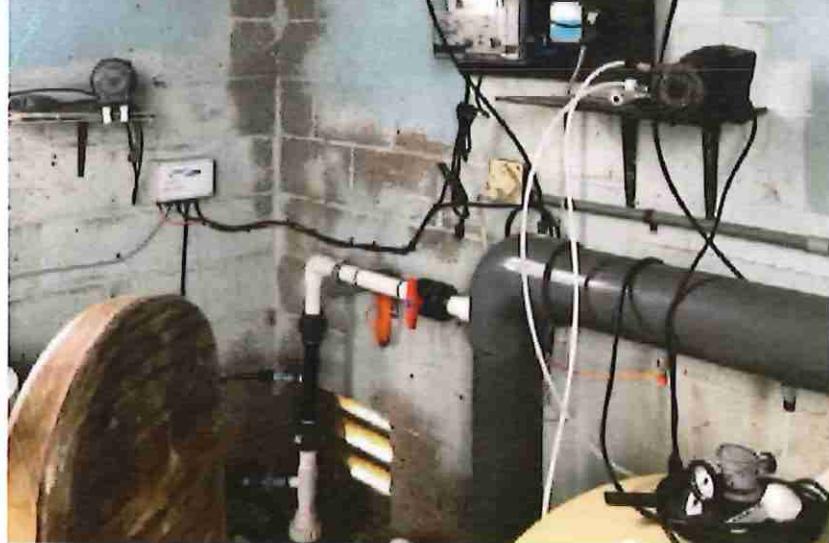
#### C. ISSUES and DEFICIENCIES - Main Pool Systems

Pool water chemistry is maintained through an automatic water chemistry controller (AQUASOL). This system includes a flow-cell that monitors pool water conditions and adds chlorine for sanitizing and corrects pH by introduction of acid. This occurs continuously.

Water sanitizer is a calcium hypochlorite erosion feeder (Pulsar). pH correction is liquid acid, fed into the system through a peristaltic pump (Stenner). This system is appropriate and, pending verification that all components are operable, suitable for continued use.
