# Mill Pond Park Pool Evaluation

Town of Newington  
131 Cedar Street  
Newington, CT 06111

March 2013

## ***ENGINEERS REPORT***

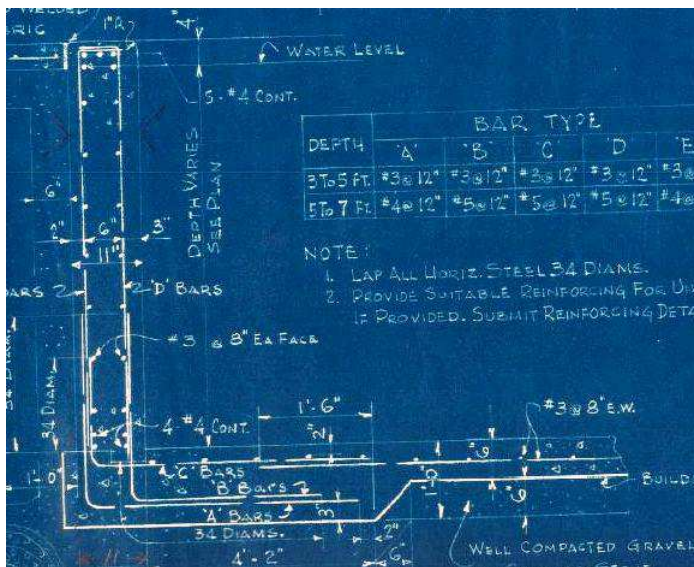
Figure 4 – Pool wall detail

The main pool consists of a "Z" shaped structure of approximately 130 feet long by 75 feet wide, and varies in depth from 3-feet to 12-feet. The original pool construction is reinforced concrete, the pool floor is poured in panels with a thickened footing around the entire perimeter. The walls were constructed on top of the floor footing and are approximately 11-inches thick. Construction plans from 1958 (Figure 4) show rebar, and expansion joints filled with joint sealant. Also

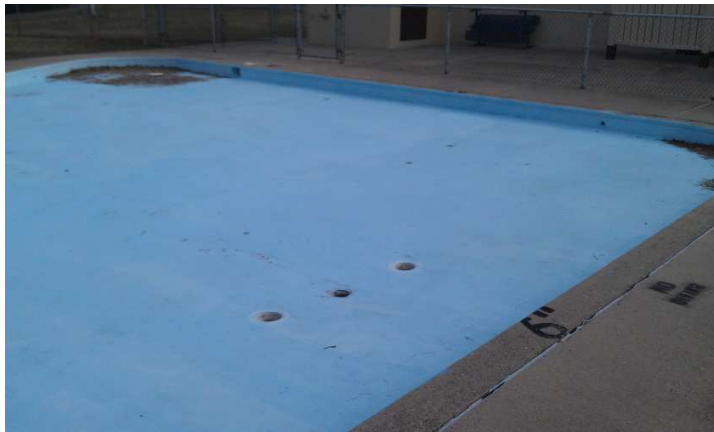
Figure 16 – Wading pool

The wading pool contains approximately 6,500 gallons. Water in the wading pool is circulated with a 1.5hp pump and filtered with a duel filter arrangement. The majority of the concrete shell appears to be in good shape with minimal cracks. As with the main pool, the caulking joints in the deck and coping around the wading pool are cracked.

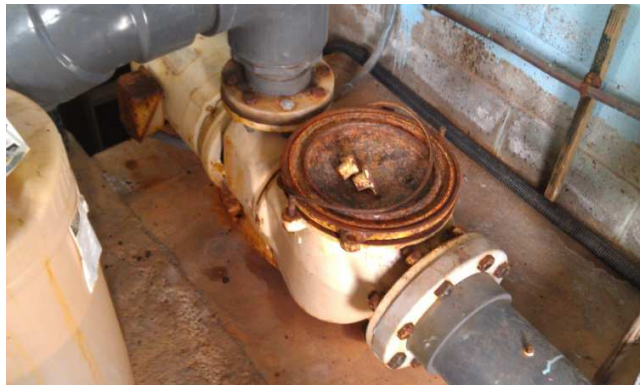
Figure 19 – Main pool pump

General corrosion inside the equipment room is apparent. Electrical panels, the pump, pipe flanges, and flange hardware are corroded. The paint on the cement block walls is delaminating (either from cement deterioration, moisture, or chemical exposure). Improved ventilation will reduce corrosion. A copper water pipe is not securely attached to the wall and is free to vibrate.

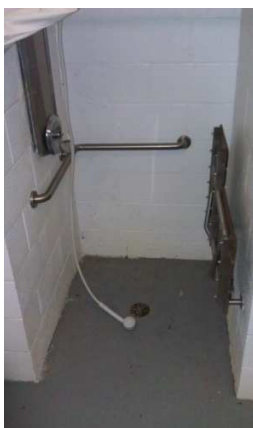
**Figure 23 – Existing handicap shower**

The bathrooms are not ADA accessible and will need to be made compliant if any major renovations are made. A handicap shower is available (Figure 23), but does not have a private enclosure for a wheelchair bound person. In multiple locations, such as the main entrance, there is greater than a ¼-inch bump in floor elevation. Floor transitions between rooms must be smooth. The four other showers share two floor drains. Each shower floor must be pitched so that water does not pass from one bather to another. It appears the original floor was not pitched correctly in the vicinity of the showers and drainage slits were cut into the floor to reduce puddling. (Figure 24)

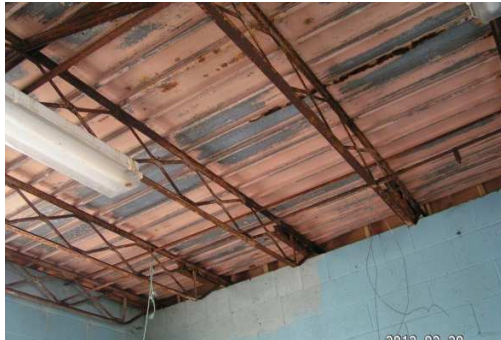
**Figure 29 – Original steel roof structure of filter building**

The original building was constructed in 1958 and renovated in 1988 at which time the roof was converted into a gable roof. The building is 90 feet long by 24 feet wide, one-story masonry bearing wall structure and does not have a basement. The original roof framing consisted of 12" deep steel bar joints spaced at 30" on center clear span across the width of the building. (Figure 29)
